September 11-13, 2013 Arvada Flood Event

Reconstruction and Documentation

**Water & Earth Technologies, Inc.
1225 Red Cedar Circle, Suite A
Fort Collins, CO 80524**

**Final Report
February 2014**

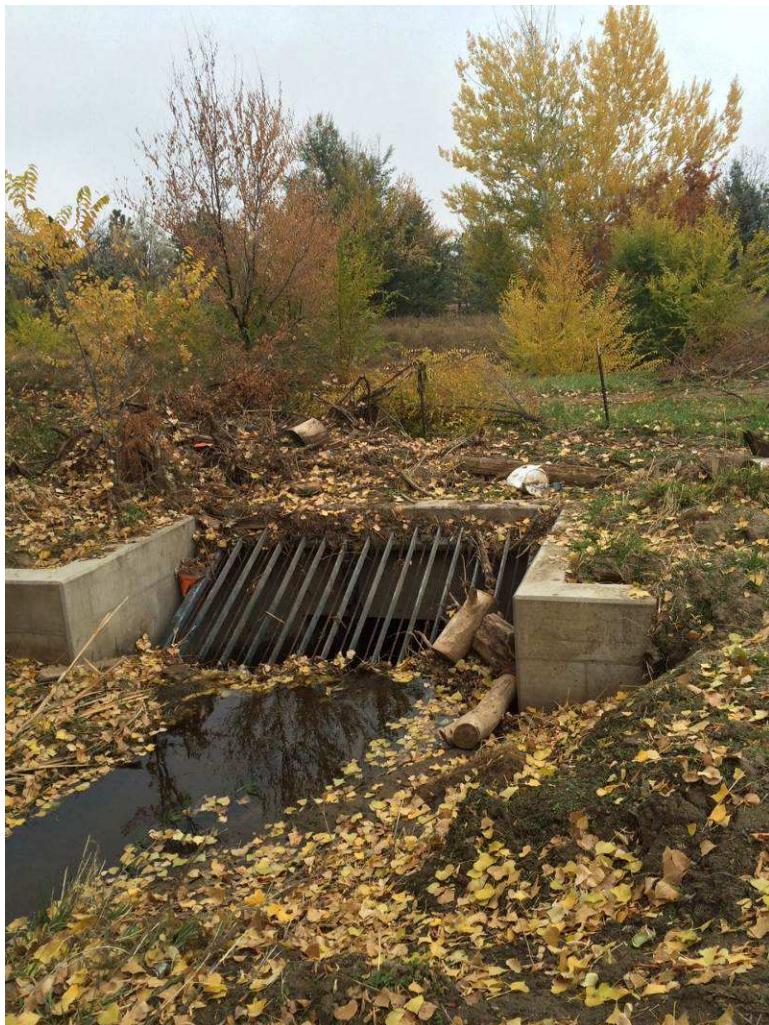
Figure 7. Entrance to Siphon Conveying Van Bibber Creek beneath the Croke Canal.

It is most likely that flows began entering the Croke Canal at the Van Bibber Creek crossing some time on the afternoon or evening of Thursday, September 12th. High water marks showing the limits of the upstream embankment's overtopping were apparent during a field inspection of the crossing, although the embankment was not damaged during the event. An estimate of inflow to the Croke Canal at Van Bibber Creek was not made, however, because the Croke Canal also received inflow from Moon Gulch (probably Thursday afternoon as well) and Ralston Creek (probably late Thursday night or early Friday morning) as described in the next section.

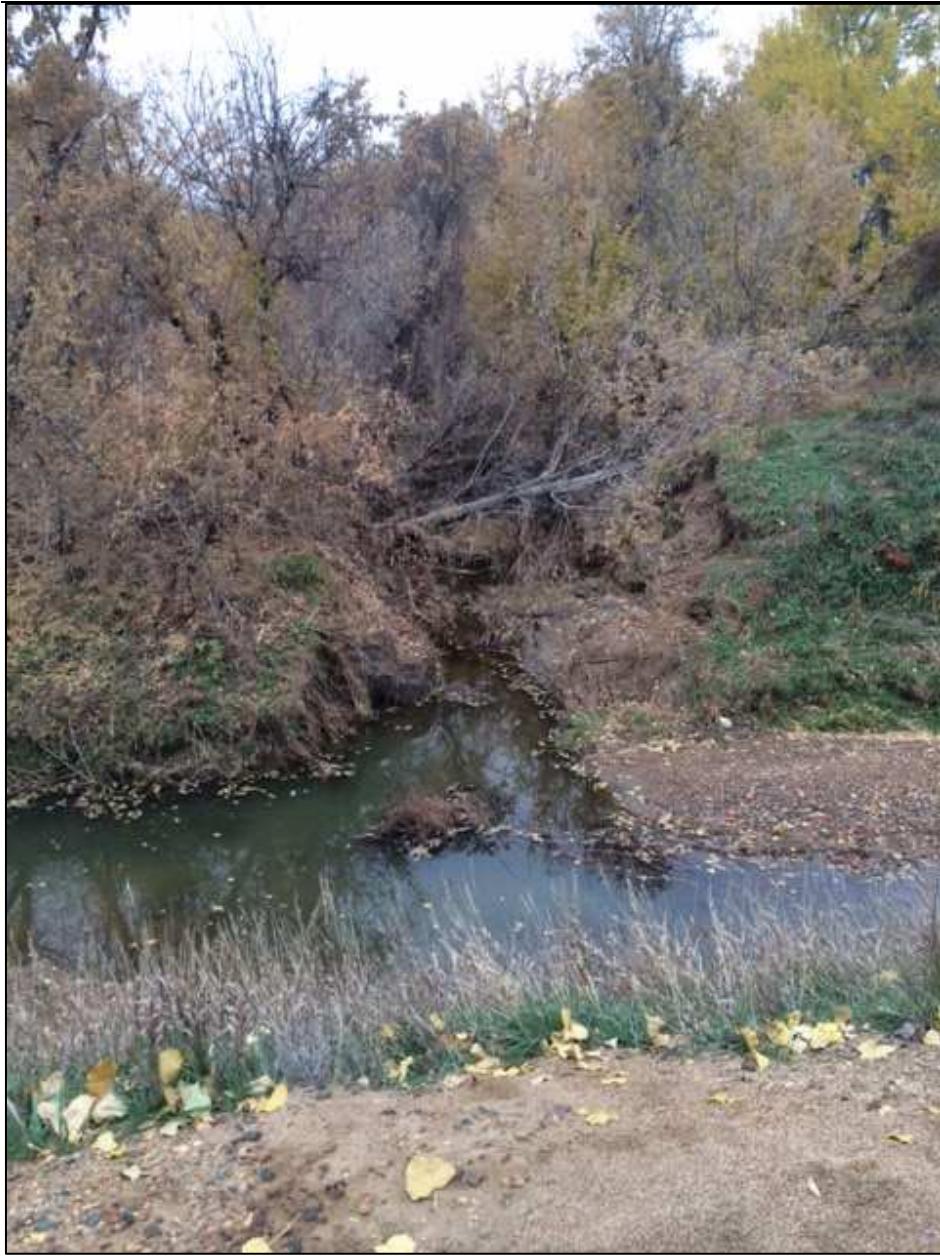
Figure 9. Ralston Creek Breach into the Croke Canal at West Woods.

The breach likely occurred late Thursday night or early Friday morning. Arvada/Blunn Reservoir began releasing water over its service spillway just after midnight (See Section 3.2.1). Given the significant flows on Ralston Creek, the Croke Canal can be assumed to have been flowing northward at its full capacity after this breach.

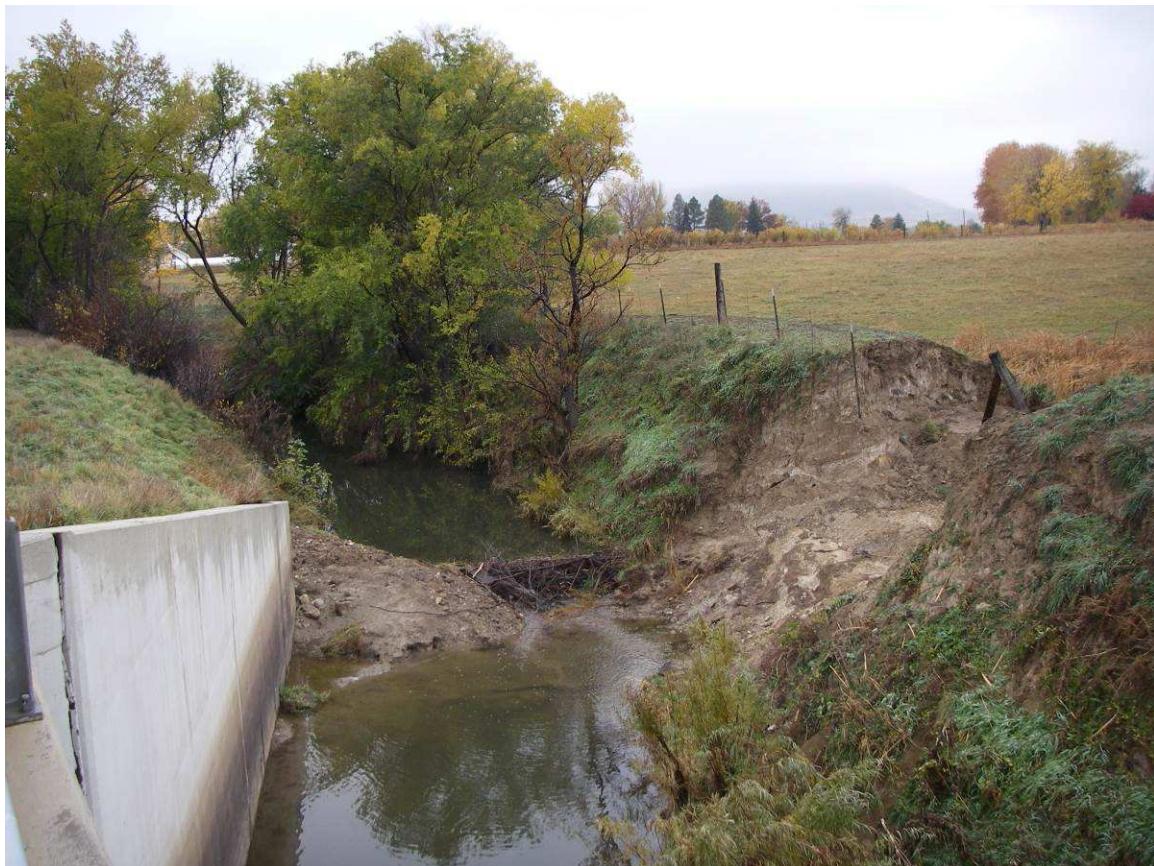
the September 11-13th storm event, the upstream embankment for the Croke Canal was overtopped and eroded away at this location, draining the majority of the detained volume of flow from Moon Gulch into the Croke (Figure 10). Arvada Public Works personnel have estimated that this breach occurred between 6:00 and 6:30 p.m. on Thursday.

Figure 10. Moon Gulch Breach into Croke Canal.

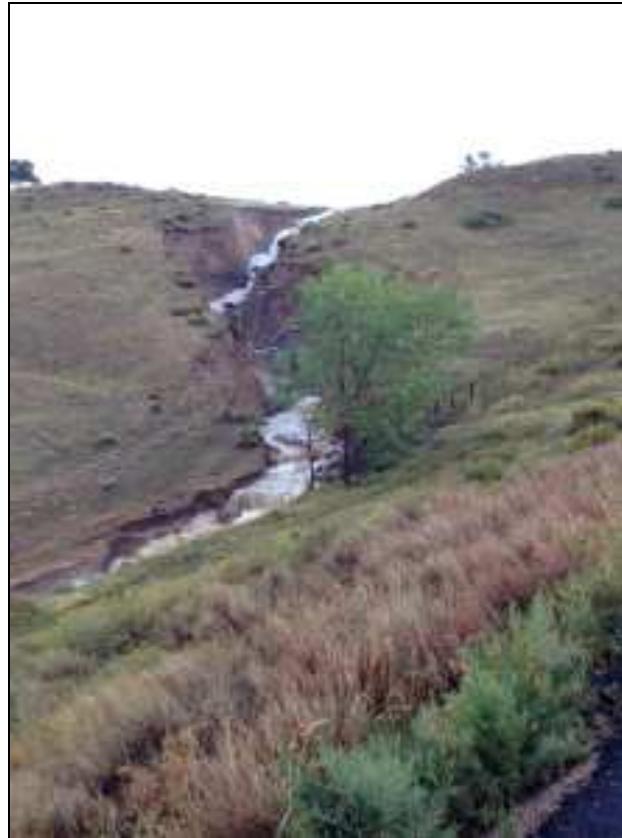
For the first time in its 76-year history, Ralston Reservoir began releasing water over its emergency spillway, just before noon on Thursday, September 12th. ALERT stage gage **110 @ Ralston Reservoir** recorded a peak stage of 49.87 ft at 21:08 pm on Thursday night, 9/12/13, corresponding to a peak discharge of 865 cfs. Design outflows from Ralston Reservoir were provided in Table 3. This peak discharge corresponds to a frequency of once in 10 to 50 years. The spillway outflow eroded a deep gully on the steep hillside that will require repairs by Denver Water (Figure 13).

Figure 13. Outflow from Ralston Reservoir. Denver Water.

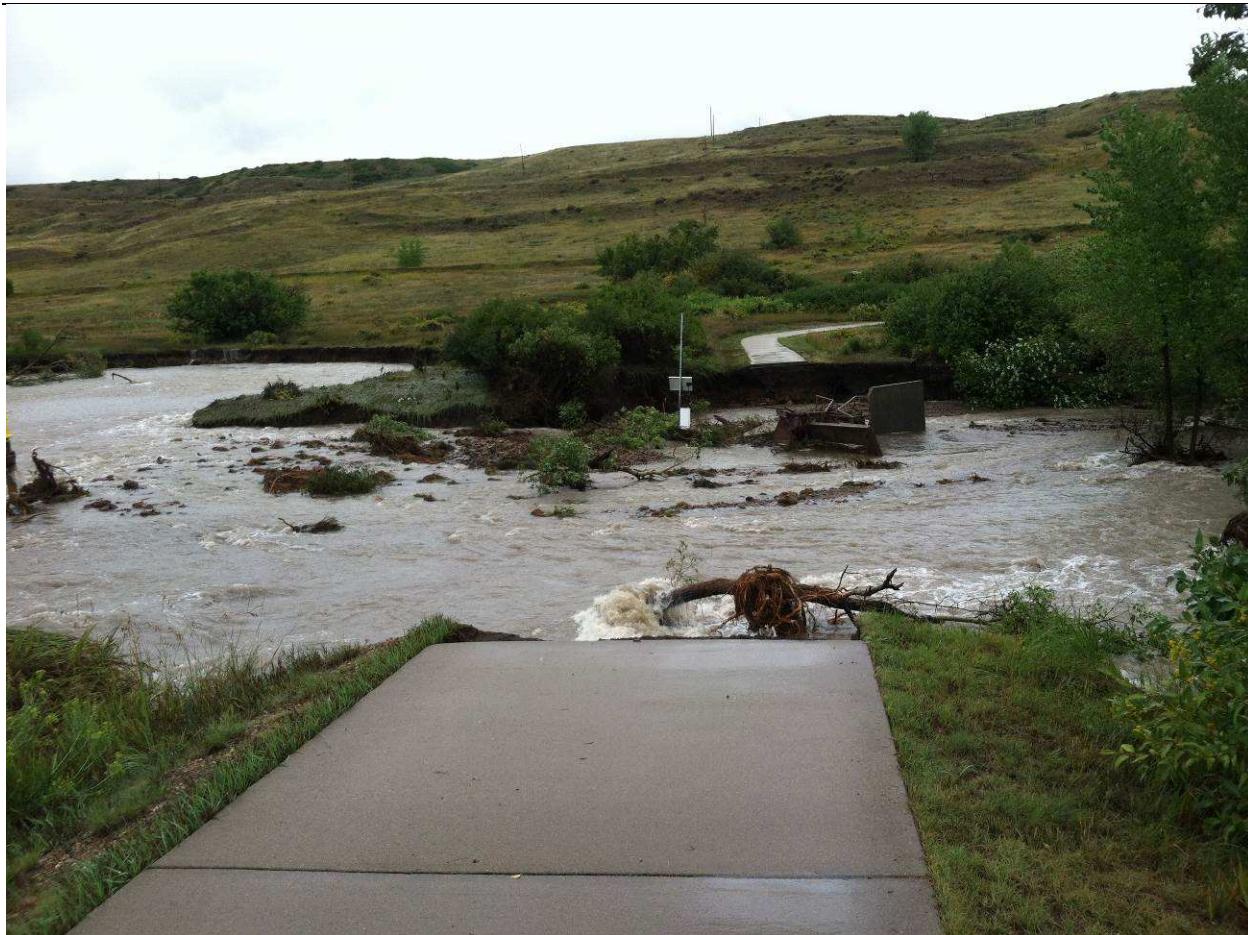
Outflow from Ralston Reservoir and runoff from the intervening tributary area enters Arvada/Blunn Reservoir through an 8-foot wide inlet channel, which suffered serious damage from erosion (Figure 14). Up to 7 feet of material was removed from reaches of the channel vertically, and bank erosion extended over a width of up to 200 ft. In addition, a water main crossing the inflow channel was exposed by the degradation.

Figure 14. Ralston Creek at the Inflow Channel for Arvada/Blunn Reservoir.

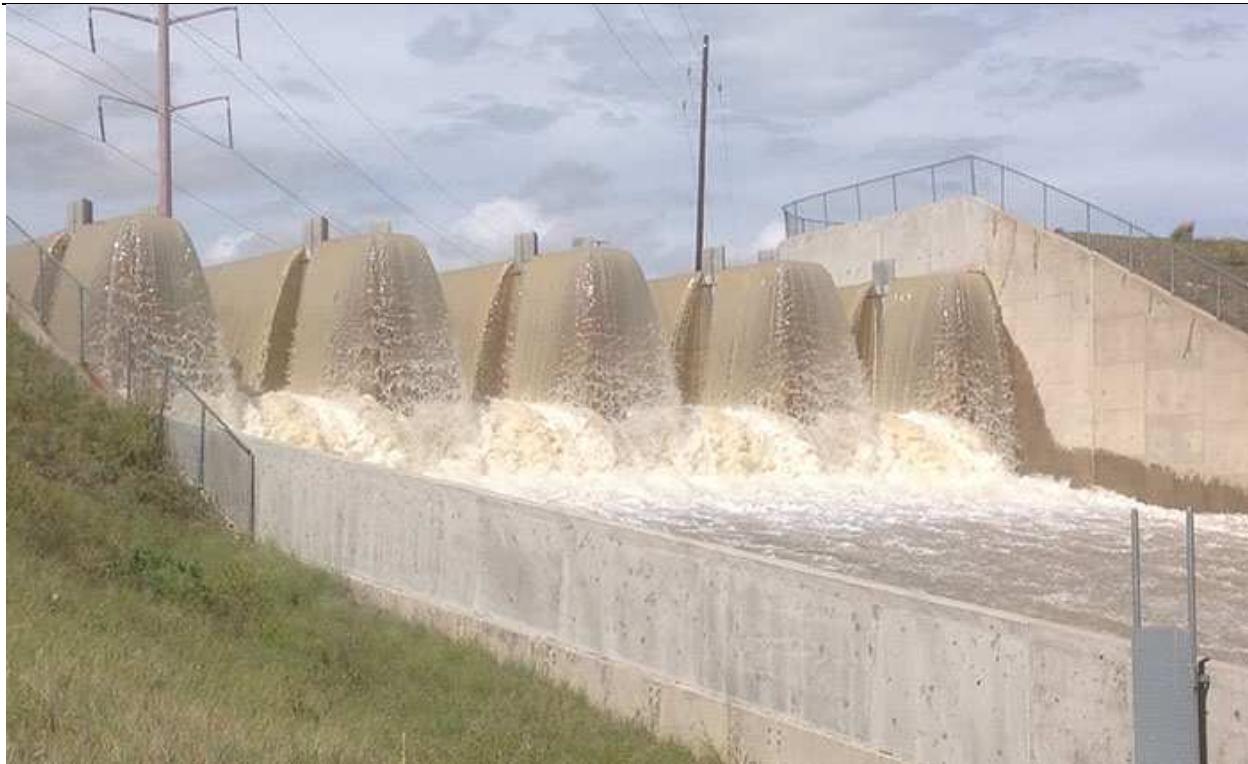
Arvada/Blunn Reservoir began releasing water over its service spillway just after midnight on Friday, September 13, 2013 (Figure 15). Arvada/Blunn Reservoir was retrofitted with a labyrinth weir spillway in late 2004, raising the crest elevation by 5 feet and increasing the 100-year discharge over the previous spillway configuration. (Design outflows from Arvada/Blunn Reservoir were provided in Table 3.) The new spillway configuration had not been activated prior to this event and there was some confusion amongst the public and the media about the meaning of the release. It was reported Friday morning that the dam had breached.

Figure 15. Release from the Arvada/Blunn Reservoir Service Spillway.

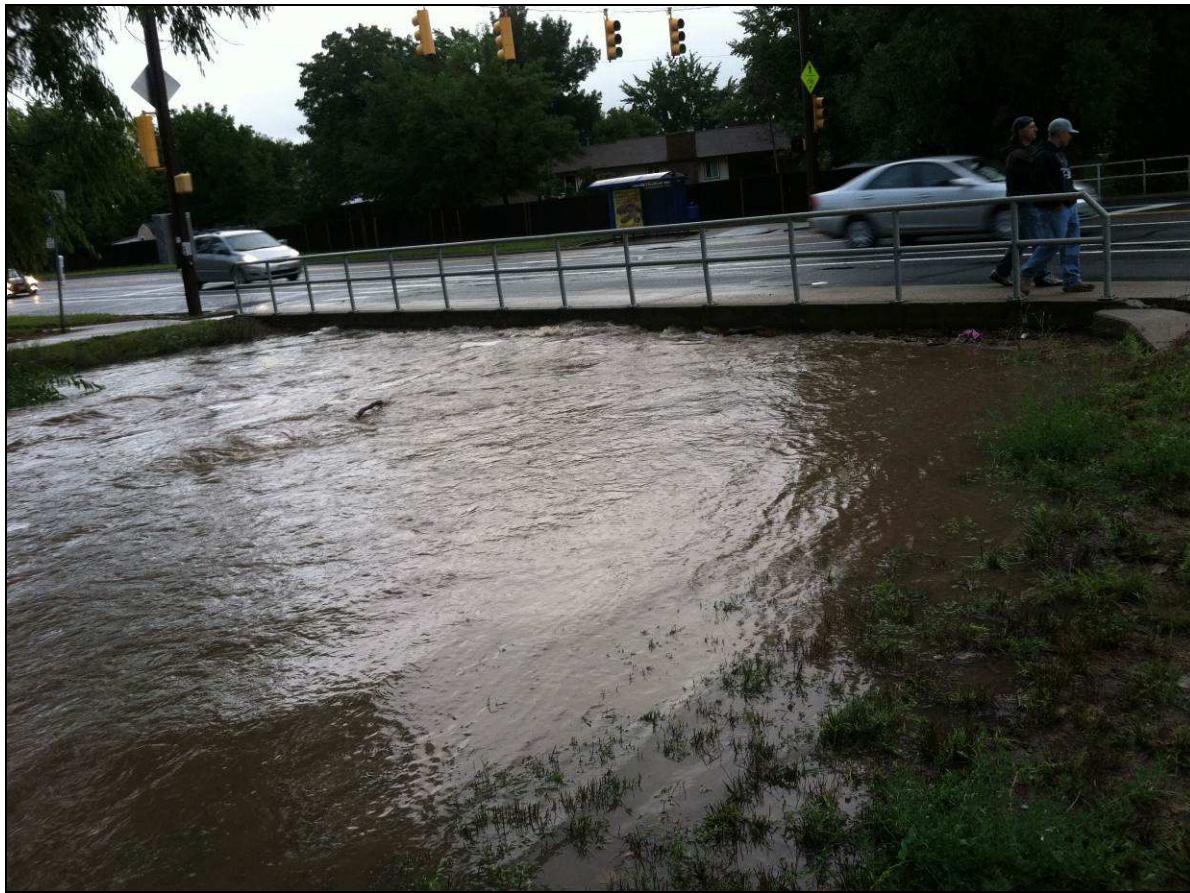
Downstream of the West Woods area, the Ward Road Bridge over Ralston Creek did not overtop but the discharge was very close to the maximum for that structure. A high water photograph was taken by City of Arvada staff (Figure 16).

Figure 16. Ward Road at Ralston Creek Peak Stage During the Flood.

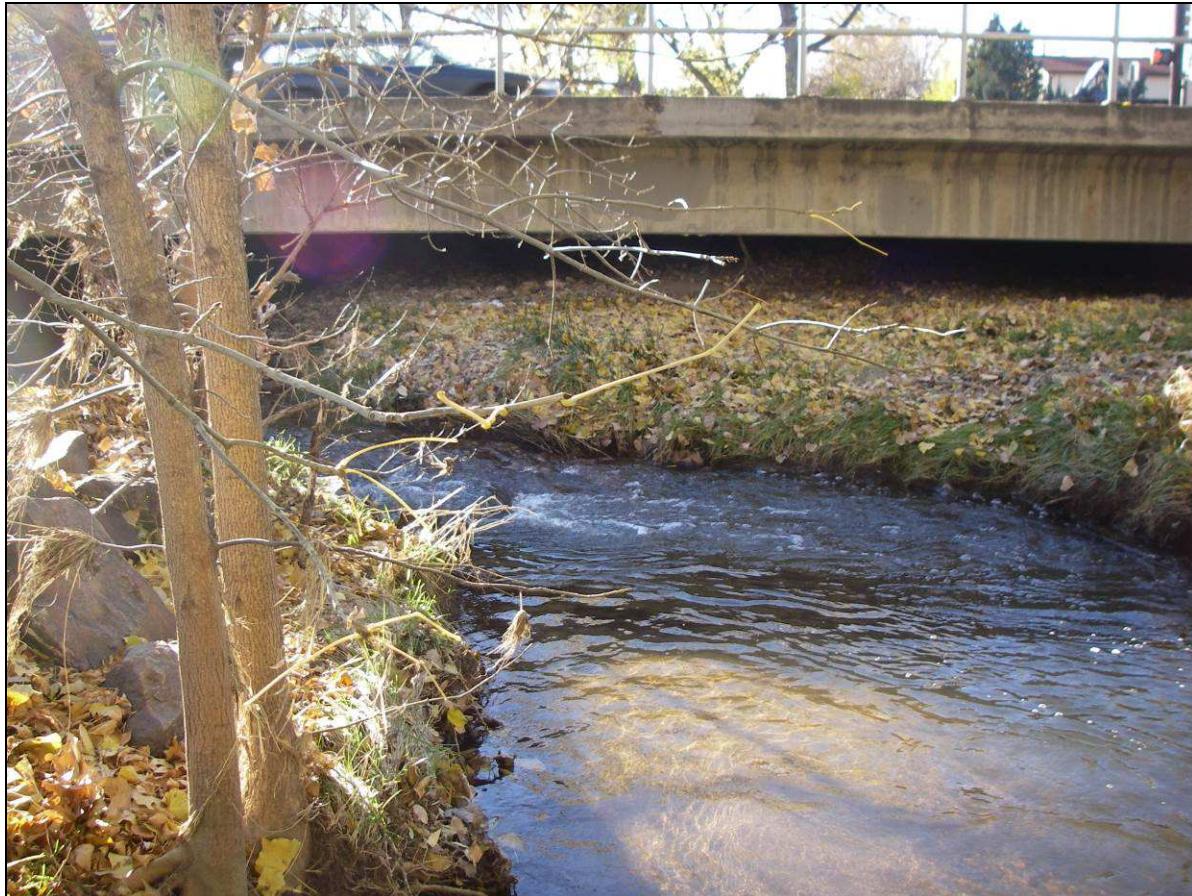
Much higher peak discharge was estimated by the rating for gage **133 Ralston @ Simms St.**, located a little more than a half mile river distance downstream from the Ward Road crossing, but still upstream of the confluence with Leyden Creek. The peak discharge at Simms St., of 1,227 cfs, occurred Friday afternoon at 4:47 p.m., just less than five hours after the peak release from Arvada/Blunn Reservoir. Given the peak discharge estimate at Ward Road, it is recommended that the rating at Simms St. be evaluated to determine if it is overestimating discharges for measured stages.

Figure 17. Ward Road at Ralston Creek After the Flood, Showing Low Capacity

3. Given the peak discharge estimate at Ward Road, it is recommended that the rating at Simms St. be evaluated to determine if it is overestimating discharges for measured stages.

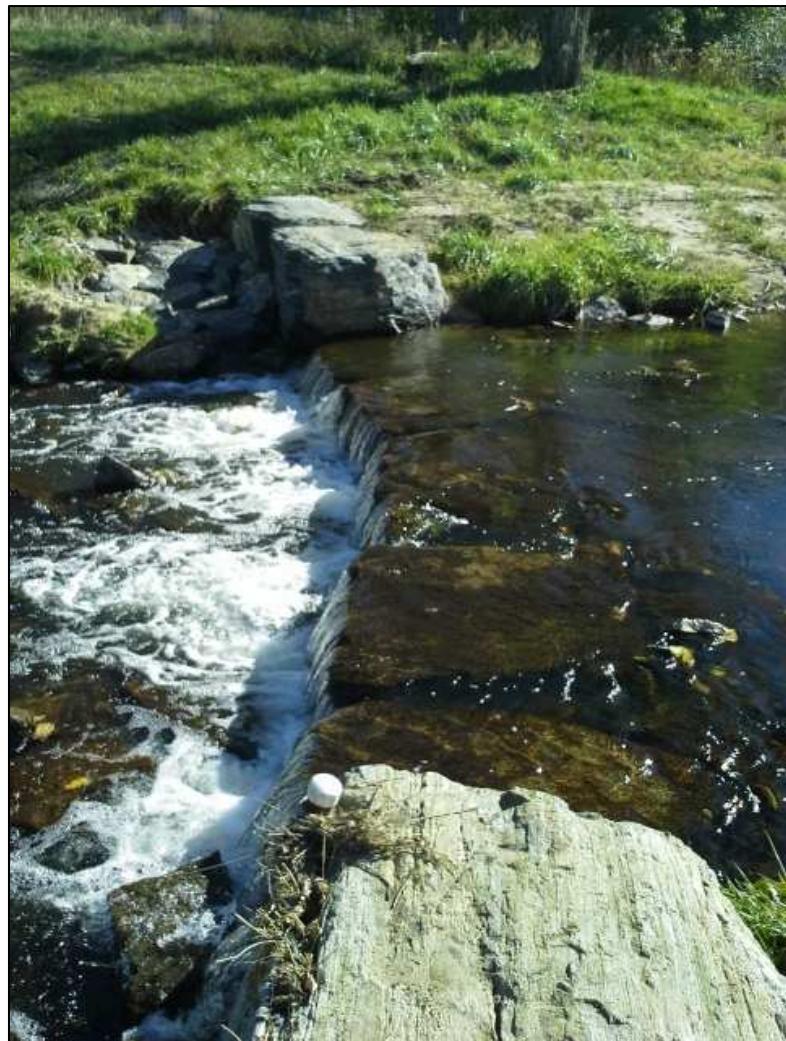
The data suggest three discrete peaks with relatively similar peak flows, but the extreme variability of the data in the final two “peaks” suggests that the gage was reading a lot of noise (due to turbulence, equipment movement due to the interim status of the installation there during re-construction, or hydraulic transience) during those peak periods. The PT for **103 Ralston @ Carr St** is installed at the base of a drop structure which could experience turbulence and entrained bubbles capable of creating pressure fluctuations at the PT (Figure 18). However, the stage associated with measured high water marks at the gage site corresponds well with the peak stage measured by the PT. The multiple peaks in the data likely reflect the offset arrival of attenuated peaks from upstream sources in the period from Thursday night to Friday morning. If those peaks had coincided, flooding in the lower reaches of Ralston Creek could have been more significant.

Figure 18. Ralston Creek at Carr Street PT Installation: Intake below Drop

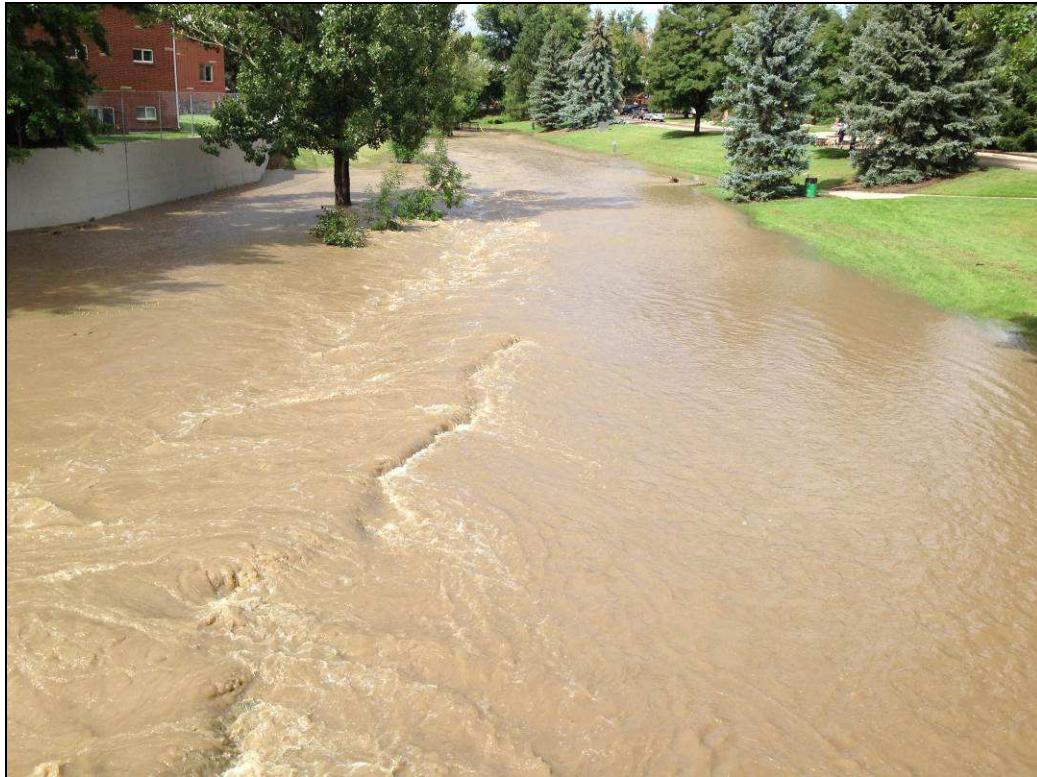
High water in Memorial Park (downstream of the Carr St. gage) is pictured in Figure 19. High water also caused concern further downstream, for residents of apartments on Pierce St. near Creekside Park. The eastern-most issue recorded during the event was the closure of Sheridan Blvd. between Ralston Road and I-76 at around 10 p.m. on Thursday the 12th. The confluence of Ralston Creek with Clear Creek occurs near this street location, but localized flooding related to ongoing construction activity there was given as the cause of the problem, and Arvada Streets personnel were dispatched to clear debris in this location as well.

Figure 19. Ralston Creek near Memorial Park

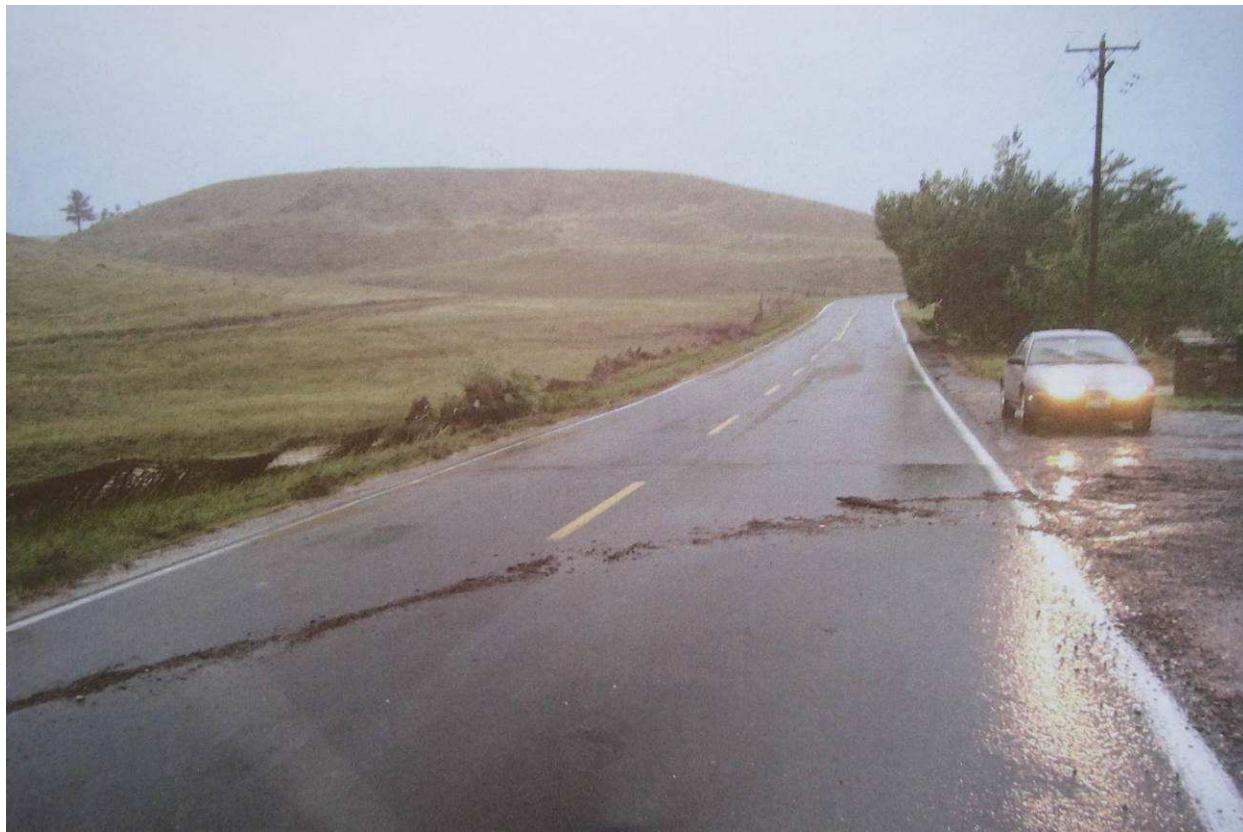
Leyden Road (West 82nd Avenue where it runs west of Indiana St.) was impacted by runoff at intermittent locations in the late evening and early morning hours of September 11th and 12th. The road was overtopped by as much as three feet at its crossing with Leyden Creek just less than a mile east of Highway 92. High water marks on the road and debris in fencing adjacent to the road are visible in Figure 22. Normally a trickle, Leyden Creek was running about 300 ft wide. Leyden Road was closed by 11:40 p.m. on September 11th between Quaker and Indiana because water and mud from adjacent construction at Leyden Rock were covering the roadway. At 5:31 a.m. the next morning, the road was closed from Indiana to Highway 93.

Figure 22. Leyden Road at Leyden Creek High Water Marks.

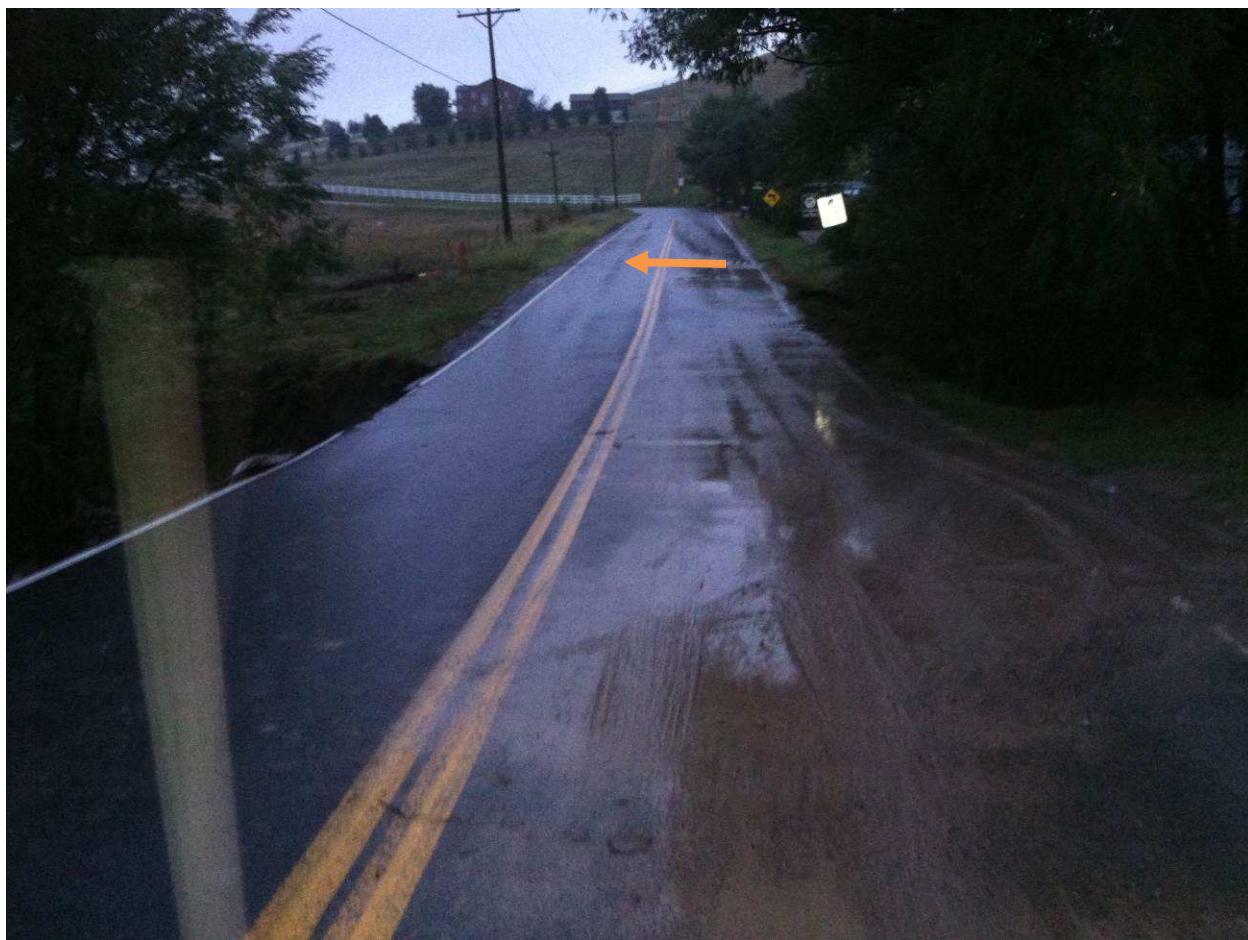
Arvada Public Works Department personnel found Quaker Street passable at Leyden Creek at 10:15 p.m. on Wednesday, September 11th, but it was overtopped shortly thereafter, and not long after that the 12-inch water main running on the east side of the road broke due to the erosion of the shoulder of the road. There was a report that Leyden Rock subdivision was without water briefly, and the water supply storage tanks dropped from about 16 feet to under 5 feet in less than an hour, but the break was isolated by 1:00 or 1:30 a.m. By reconfiguring the water supply, service to the Leyden Rock and Candella subdivisions was maintained without a sustained interruption in the provision of drinking water. To best conserve the remaining water in storage, it was decided not to flush the lines. It is possible that some customers experienced air in the water lines. Figure 23 shows Quaker St. in the aftermath of the flooding.

Arvada Public Works Department personnel indicated that the first flood in the early hours of Thursday morning was followed by a second, higher peak on Thursday morning that interrupted crews working to repair the damage. In addition to the road and water infrastructure damage, two homes in the Township of Leyden suffered flood damage. Arvada police assisted Jefferson County with the evacuation of Leyden on the afternoon of 9/12/2013.

Figure 23. Quaker Street at Leyden Creek.

Quaker Street was repaired and reopened by September 18, 2013.

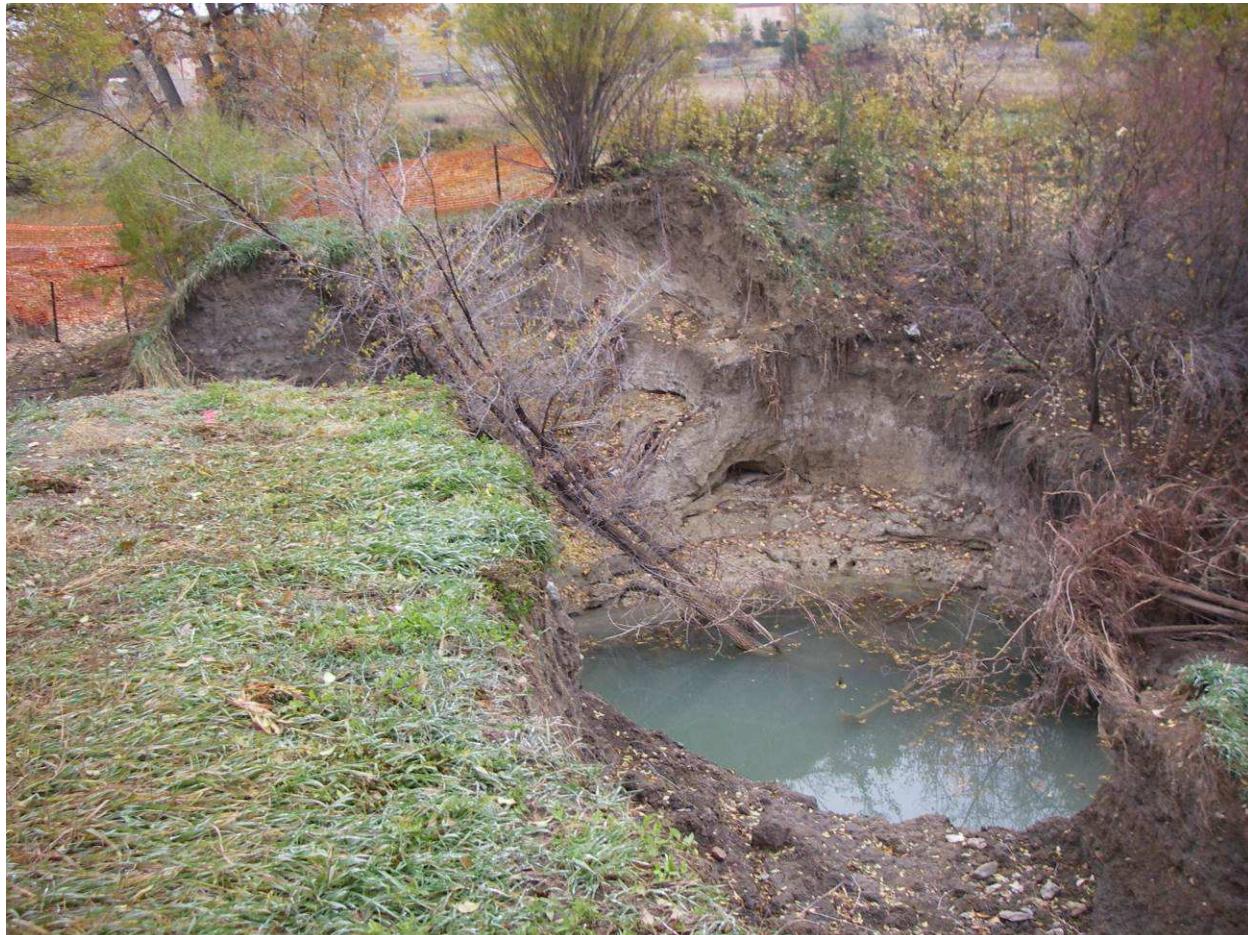
The Church Ditch crosses Leyden Creek downstream of the Quaker Street crossing and just upstream of the Leyden Lake. At some point during the September 11th-13th event the ditch embankment at the crossing was breached (Figure 24), diverting flows in the Church Ditch into the Leyden Detention facility. The capacity of the Church Ditch exceeds its decree for 113 cfs and was estimated at 200 cfs by Arvada Public Works personnel.

Figure 24. Leyden Creek Breach of the Church Ditch Upstream of Leyden Reservoir.

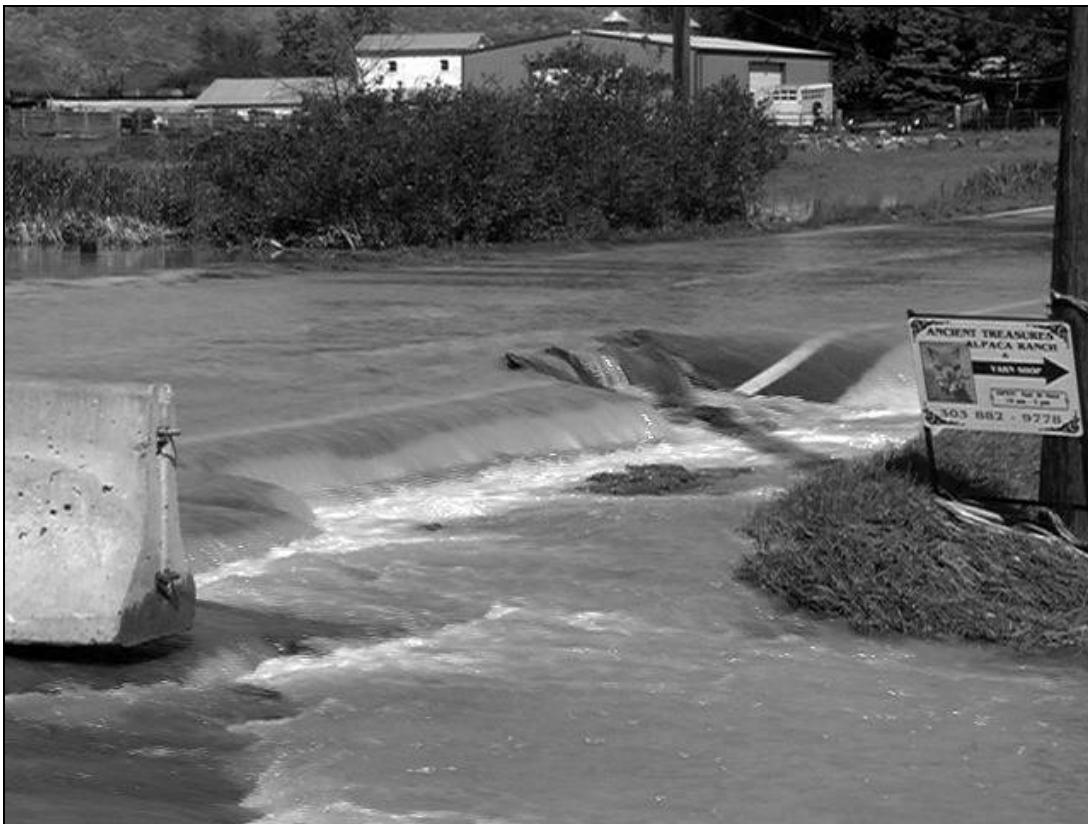
The conveyance for Leyden Creek beneath Indiana during the event (a 36" and an 18" pipe) was known to have inadequate capacity prior to the September flooding. The overtopping of Indiana St. by flows in Leyden Creek is a relatively frequent event, according to Arvada Public Works Department personnel. Its overtopping during the September 11th-13th flood event preceded the release from the Leyden Detention spillway and may have been exacerbated by debris clogging the culverts. By 11:00 or 11:30 p.m. on Wednesday night it had been reported that 3 inches of

flow was passing over Indiana Street and ultimately the roadway was inundated by flows up to a foot deep (Figure 27). The east shoulder of Indiana St. was eroded, exposing an 18" water main encased in a 36" concrete pipe (Figure 28). Arvada was able to quickly mobilize a contractor to place a line of concrete jersey barriers to stabilize the water main and it did not break during the event. Repairs to the road after the September 11th – 13th event included upgrading the conveyance for Leyden Creek beneath Indiana St. to triple 36" CMPs. Additional improvements are planned by CDOT but awaiting the completion of the Northwest Bypass. Indiana Street was the last street to reopen after the September flooding, on Wednesday, October 16.

Figure 27. Overtopping of Indiana Street (Looking Northeast).

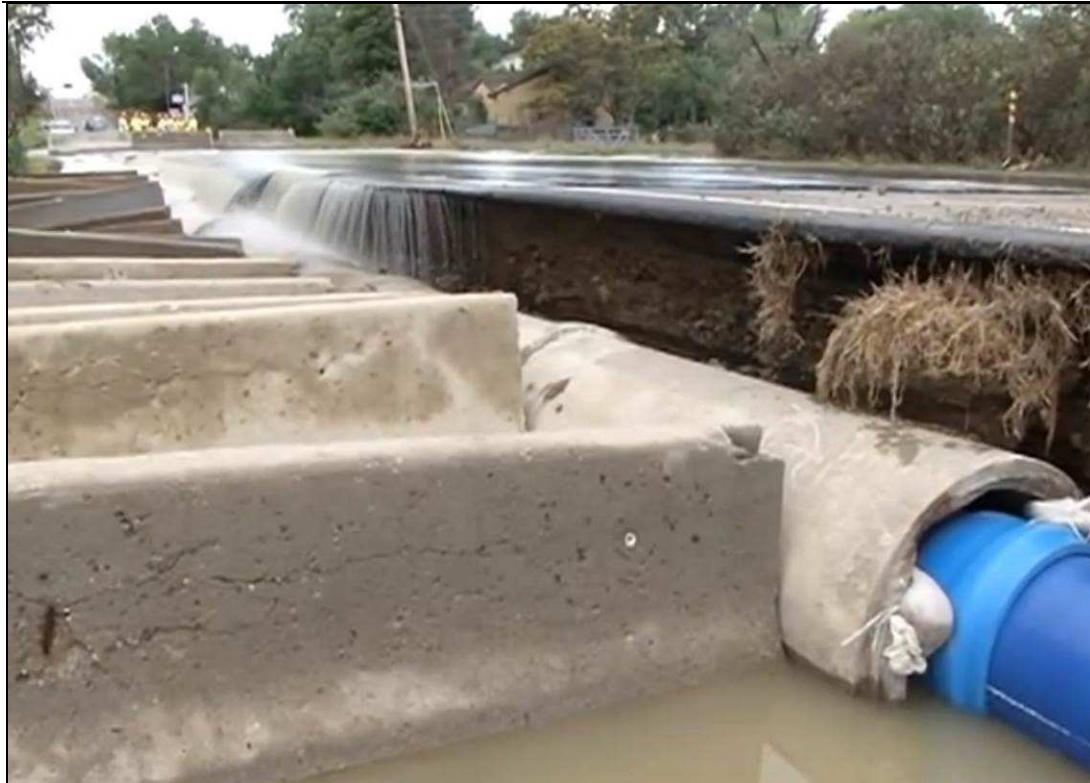
Flow over the spillway at Leyden Dam caused significant flooding in areas east of Indiana St., extending to Alkire Street and scattered locations beyond during the evening of Thursday, September 12, 2013. Immediately east of Indiana St., Leyden Creek passes beneath the Croke Canal in a siphon. The capacity of that conveyance was exceeded Thursday night and backwater behind the siphon overtopped the Croke Canal's upstream and downstream embankments, with flow returning to Leyden Creek through corrals and pastures adjacent to the canal. Leyden Creek flows through an unplatted County area occupied by large rural lots of 20-40 acres in the reach between Indiana and Eldridge Streets.

Figure 28. Water Main Damage at Indiana Street (Looking South East).

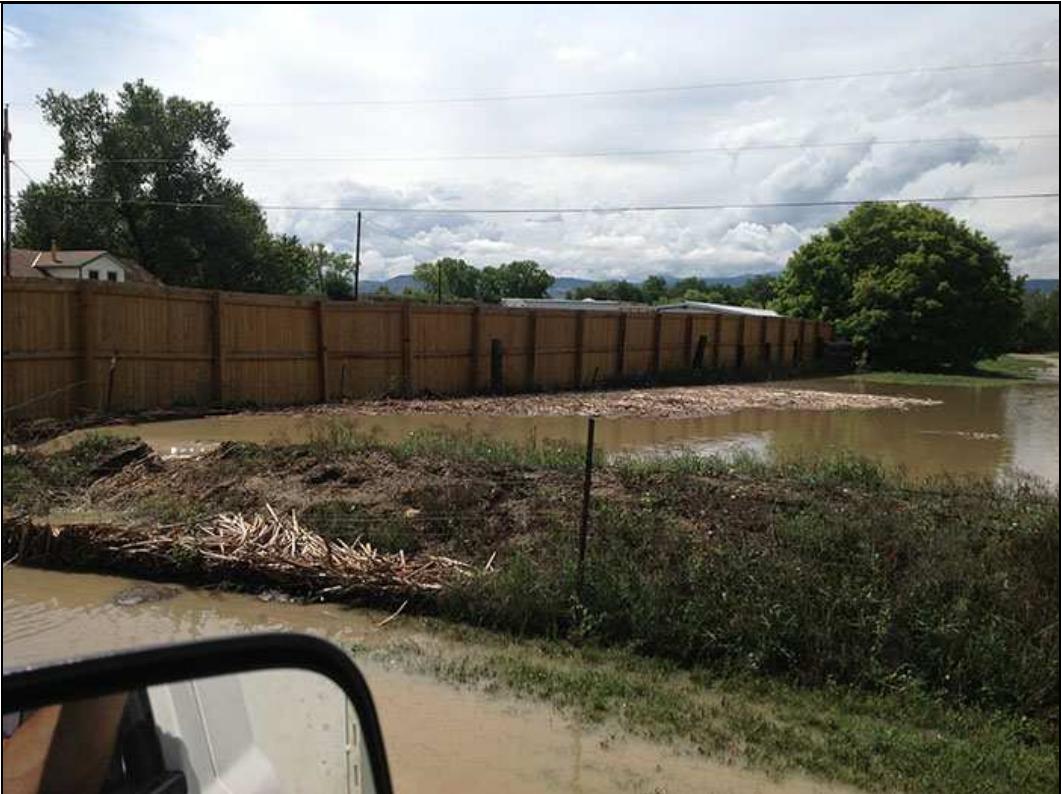
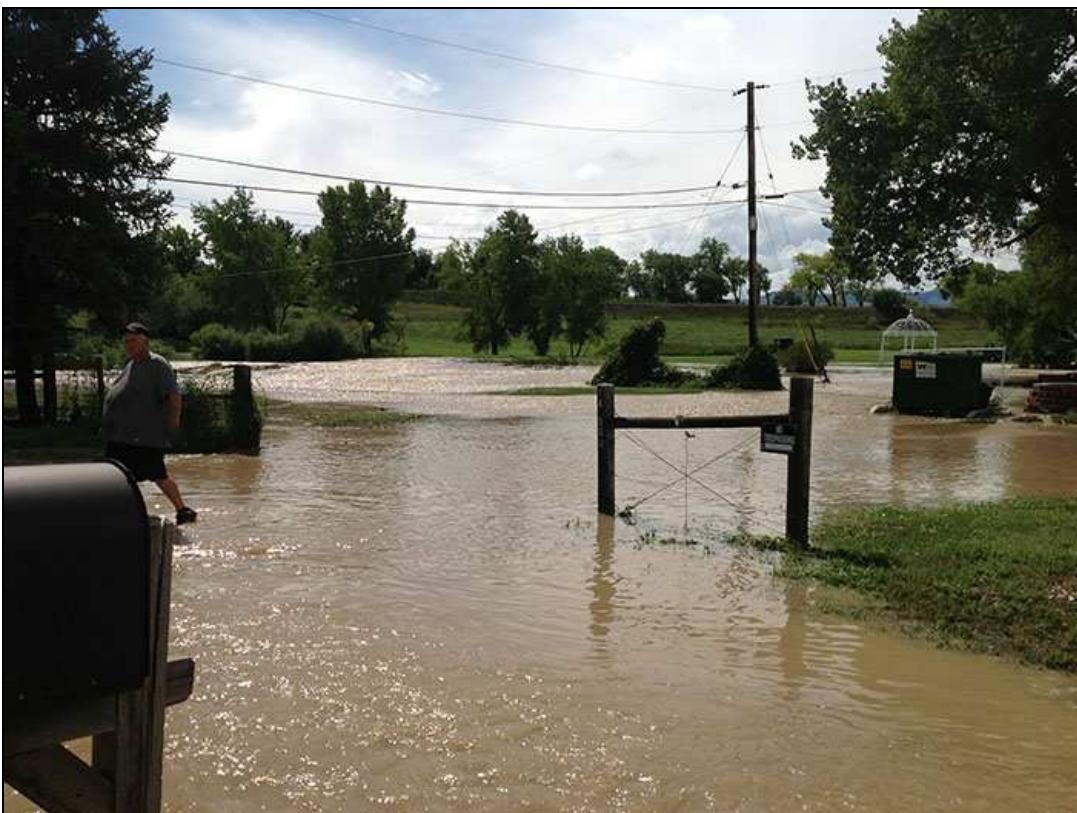
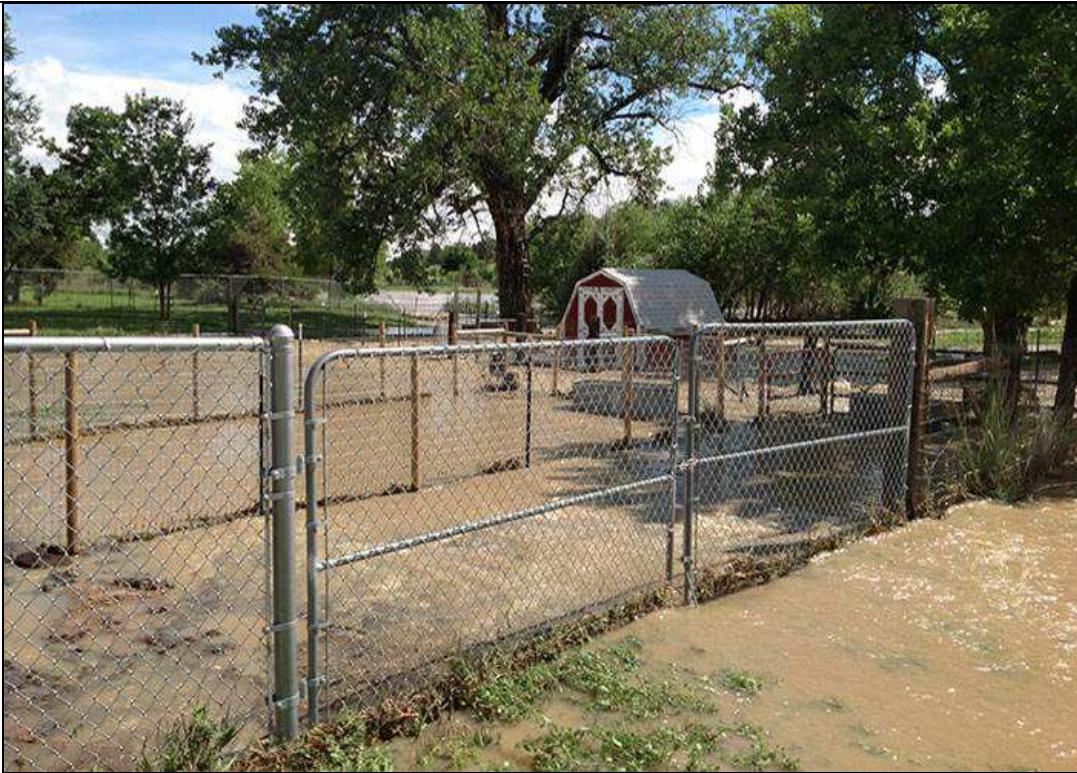
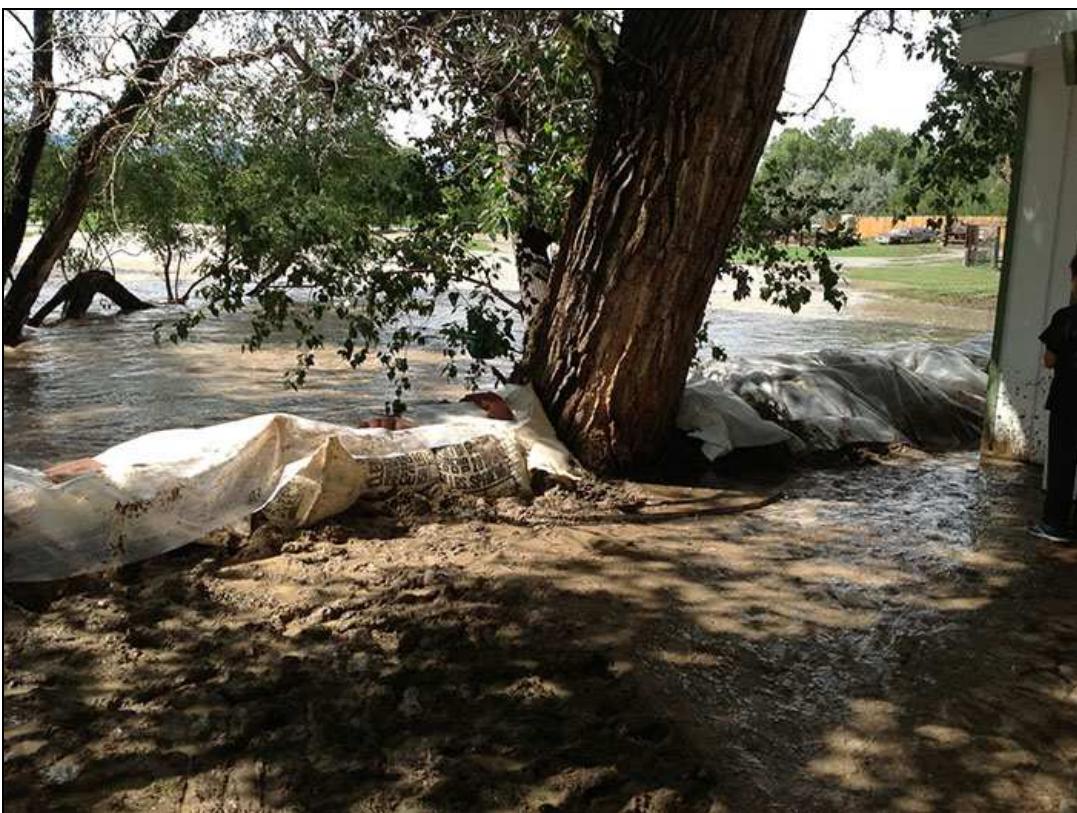
The portion of the Cameo Estates neighborhood lying between Eldridge St. and Alkire St. was hard hit (Figure 29 - Figure 32), with widespread flooding in pastures, yards, and streets, as well as damage to several homes. At the time of the flood, this western portion of Cameo Estates had been annexed into the City and had received City water and sewer service. However, this neighborhood retained stormwater conveyance infrastructure typical of County development, with driveways served by small culverts placed in inconsistent drainage ditches along streets, rather than curb, gutter and storm sewers. In several places along this reach, residents of these 1 to 2-acres lots had created small ponds by building small structures in the Creek.

Figure 29 Cameo Estates Flooding.

Figure 30 Cameo Estates Flooding.

Figure 31 Cameo Estates Flooding.

Figure 32 Cameo Estates Flooding.

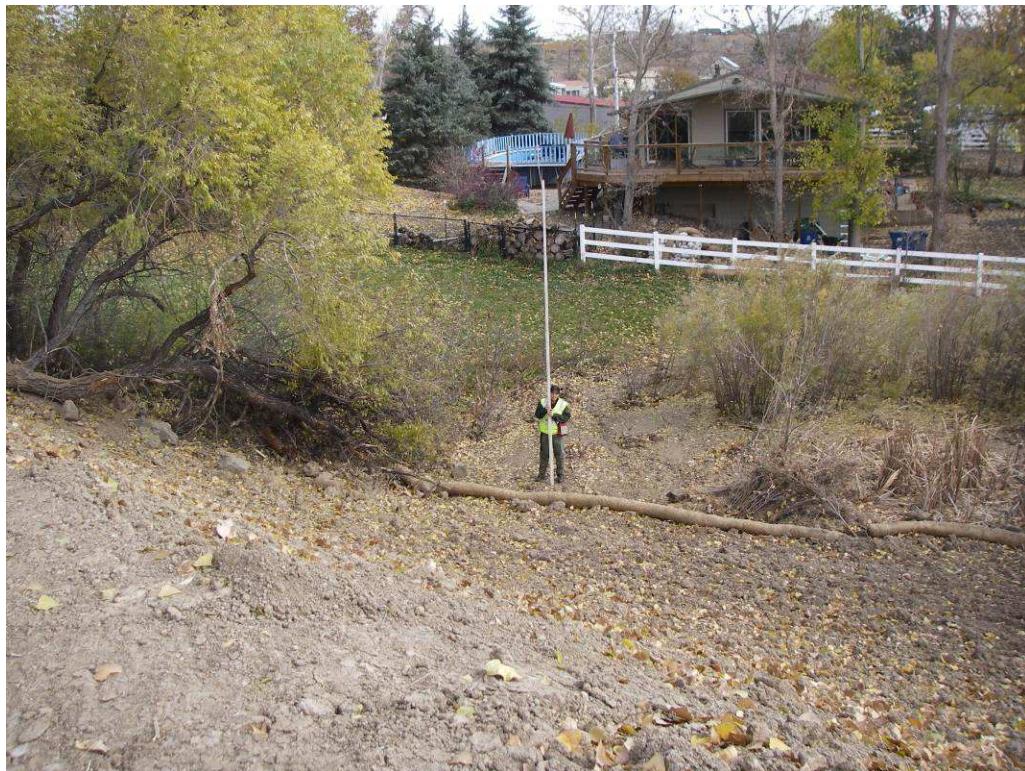
the Croke Canal on the other side of the embankment was found to be 5.51 feet higher than the native ground where the rod is shown in Figure 34. An uncontrolled breach at this location would have emptied the entire contents of the Croke Canal, from both the upstream and downstream sides, into the Cameo Estates subdivision. In contrast, the invert of the Croke Canal at the site of the intentional opening near Indiana Street (Figure 35) lies 2.12 ft lower than the invert of Leyden Creek on the downstream side of the embankment there (Figure 36).

Figure 34. Location of Averted Breach of the Croke Canal Embankment.
