September 11-13, 2013 Arvada Flood Event

Reconstruction and Documentation

**Water & Earth Technologies, Inc.
1225 Red Cedar Circle, Suite A
Fort Collins, CO 80524**

**Final Report
February 2014**

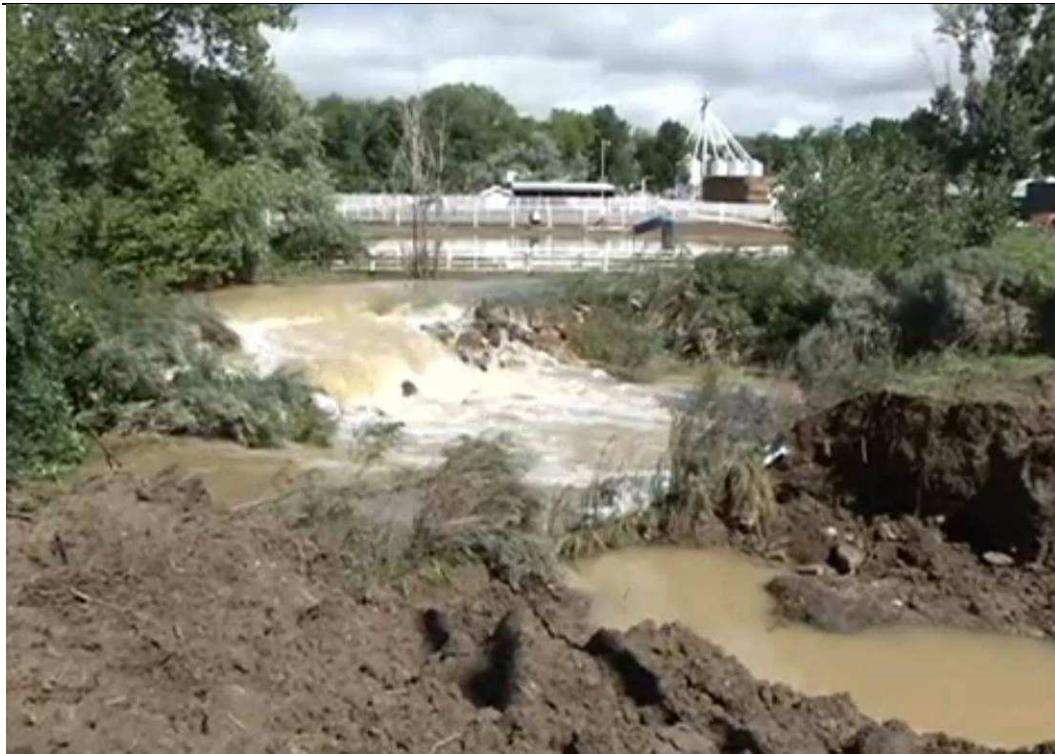
Digging began shortly after 11:00 a.m. at the intentional release location and the release of water was reported at 11:18 a.m. The release lowered the water level in the Croke Canal by 4-5 inches in the first 22 minutes, by 15 inches in an hour and by 18 inches after 3 hours and 40 minutes, based upon reports to the City of Arvada Police (Appendix B). City of Arvada personnel were cognizant that the release could create a second flood peak in areas that had already been flooded the previous night. Downstream areas were monitored throughout the release and ultimately the flood peak created by the intentional release at Indiana St. caused a flood peak estimated at 0.5 feet below the peak from the previous evening. Flow from the controlled release was monitored during the release at Alkire St. and 75th Avenue.

Figure 35. Flooding Into The Croke Canal Below Indiana St. (Background) and the Location of the Controlled Release From The Croke Canal (Foreground).

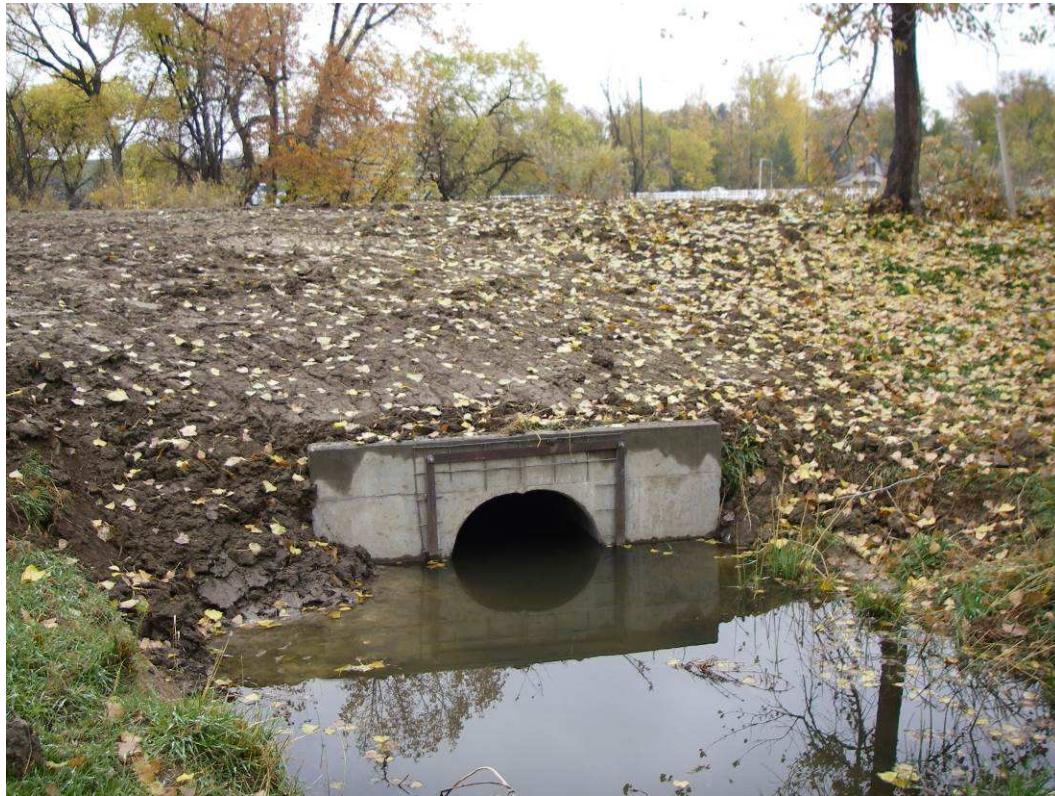
Figure 36. Conveyance for Leyden Creek Beneath the Croke Canal (After Repairs)

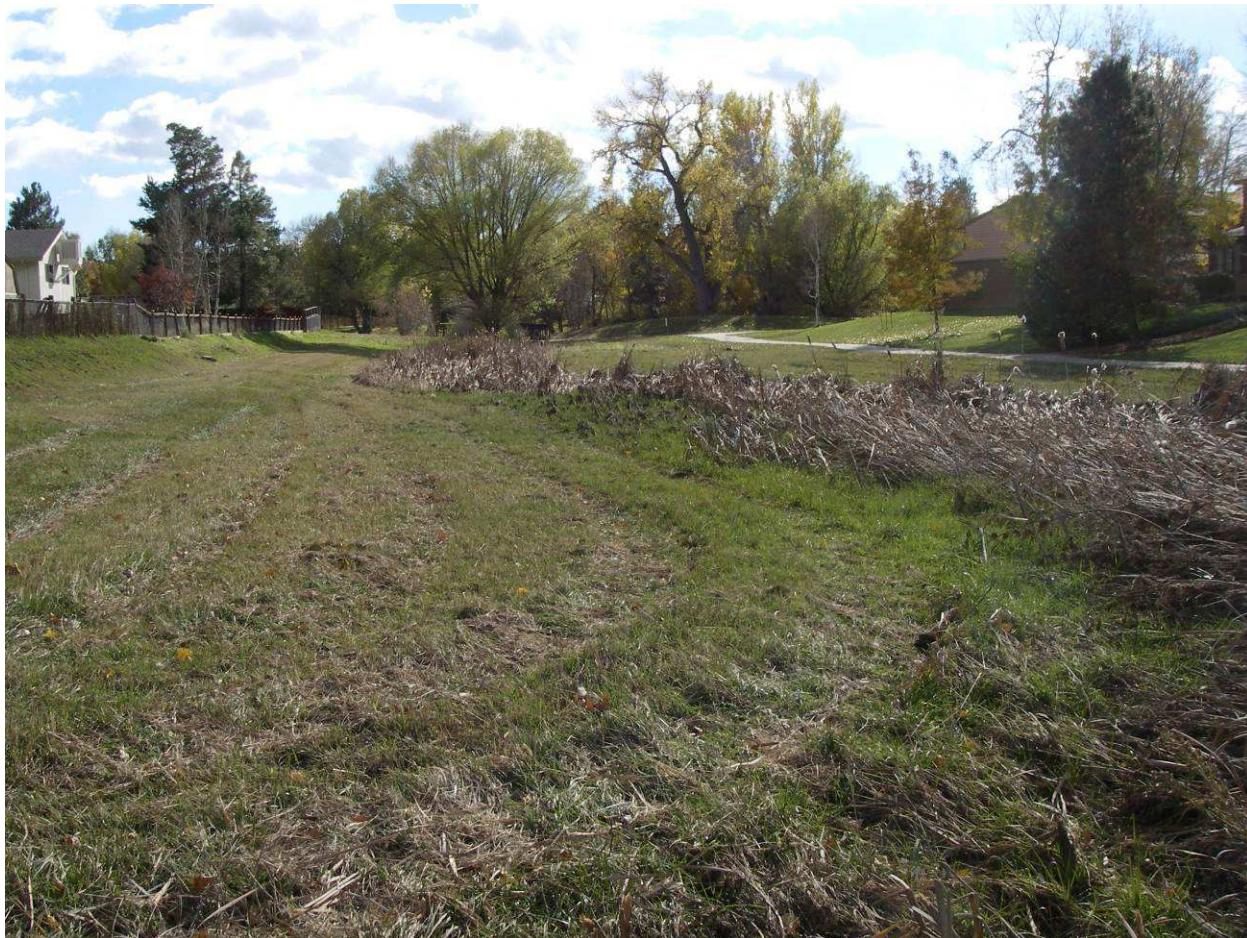
At the time of the flood event, the rating for gage **213 Leyden Confluence** estimated the first, larger peak flow at 2,903 cfs. This discharge is well in excess of the peak discharge estimated by the Leyden Dam gage. To field-truth this discharge value, a peak flow estimate was made using high water marks and channel geometry surveyed on November 1st, 2013. The surveyed high water marks were lower than the peak stage measured by the PT by 0.33 ft. However, the modest capacity of the low flow channel in the monitored reach, the mild channel slope and the significant growth of vegetation including cattails and willows (Figure 37) suggested that the rating was seriously overestimating flows for the gage. The reach is not capable of passing the very large discharge predicted by the rating without a substantially higher water surface elevation.

Figure 37. Leyden Creek at Its Mouth.
