September 11-13, 2013 Arvada Flood Event

Reconstruction and Documentation

**Water & Earth Technologies, Inc.
1225 Red Cedar Circle, Suite A
Fort Collins, CO 80524**

**Final Report
February 2014**

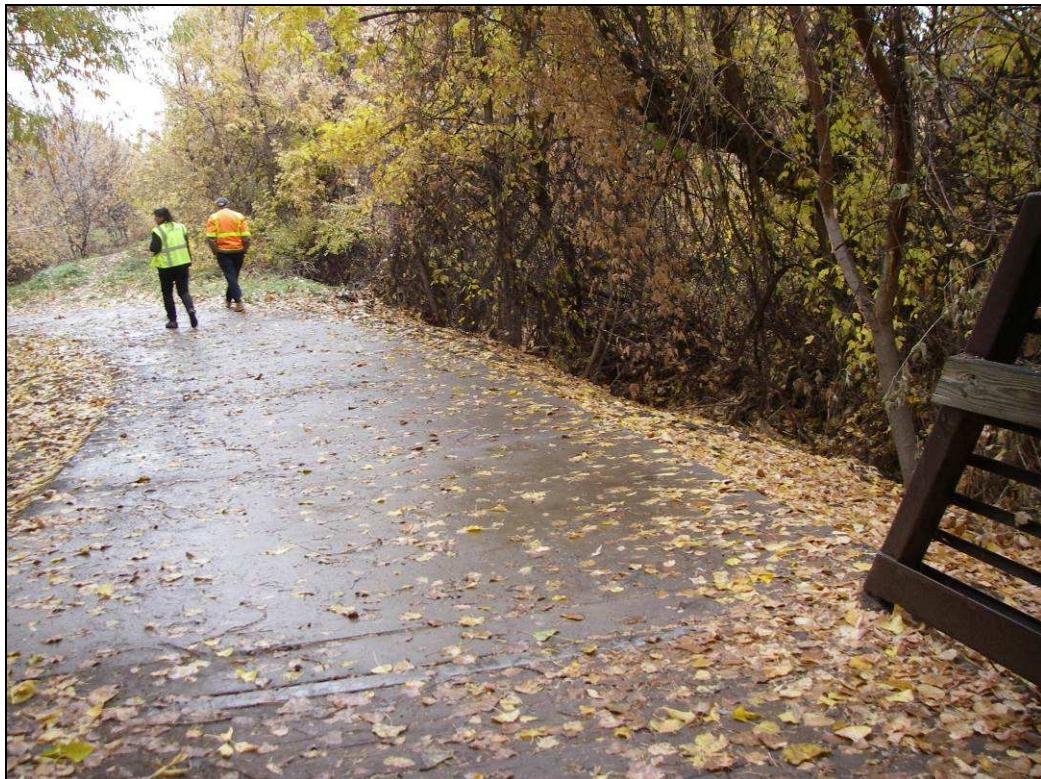
Figure 8. Ralston Creek Pedestrian Bridge at West Woods

During the September 11-13th flood event, Arvada Public Works personnel were monitoring Ralston Creek at its crossing with the Croke. Very minor discharge into the Croke at the flow separation structure's spillway was eventually observed, but even that minor release had stopped by Friday at noon, although the water levels remained high in both creek and canal. However, after the waters had receded and access to creek-side natural areas to the north of the flow separation structure was re-established, it became clear that Ralston Creek flows had become rerouted into the Croke canal during the flood at another location. Ralston Creek had backed up behind a pedestrian bridge blocked by a debris dam (Figure 8) and had overflowed to the north, where flows impeded upon the upstream embankment of the Croke canal and eventually breached it (Figure 9).

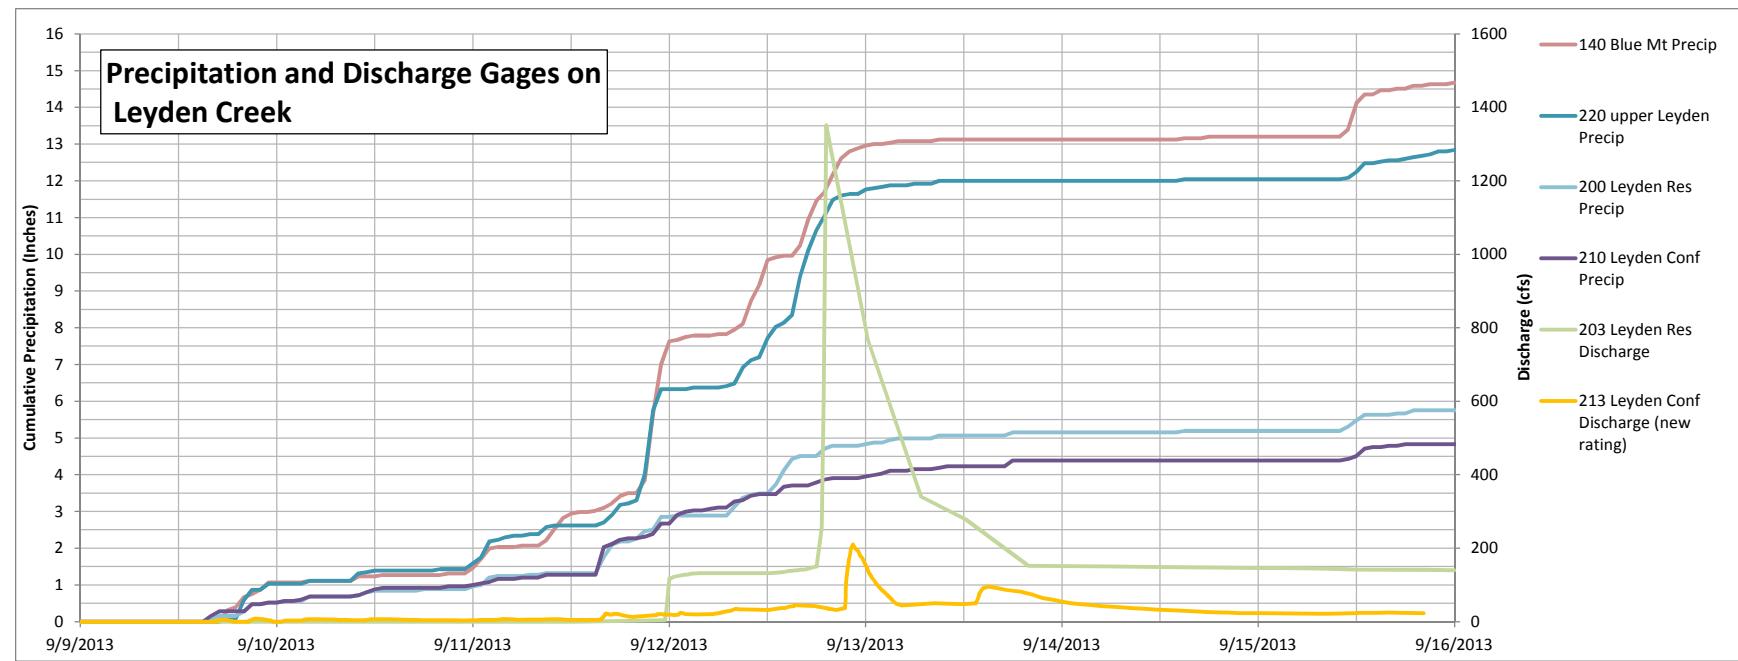
Figure 20. Precipitation and Discharge Data for Leyden Creek. The Leyden Confluence Discharges are Calculated with a Provisional (Based upon the Peak Flow Estimate Survey Conducted after the September Flood Event).

Figure 20 shows cumulative precipitation at the Leyden Creek gages, superimposed on the discharge plots for Gages **203 Leyden Reservoir** and **213 Leyden Confluence**. The figure will be referred to during discussions of flood impacts in the Leyden Creek watershed. Table 7 shows historic annual peaks for the two discharge gages on Leyden Creek, **203 Leyden Reservoir** and **213 Leyden Confluence**. The 2013 peak value is a new historical peak for gage **203 Leyden Reservoir**, but the September 2013 value was exceeded in 1995 at **213 Leyden Confluence**.

At the mouth of Leyden Creek, gage **213 Leyden Confluence** registered two distinct peaks, as shown on Figure 20. A peak stage of 3.82 ft. was measured at 22:26 on Thursday night September 12th, 3 hours and 14 minutes after the peak release at Leyden Dam. A second much smaller peak, with a maximum measured stage of 3.0 ft, occurred at 3:04 on Friday afternoon, 3 hours and 45 minutes after the beginning of the controlled release through the opening of the Croke Canal (which was reported in the Arvada police logs to have begun sometime between 11:13 and 11:18 a.m.). These peaks do suggest a consistent but long travel time for (attenuated) peak flows between these two locations.

The peak discharge estimate was made using a simplified HEC-RAS model of reach hydraulics. The resulting peak discharge estimate is 160 to 300 cfs. It is strongly recommended that a new rating be developed for gage **213 Leyden Confluence**. The flow data shown on Figure 20 were re-calculated using the output from the simplified HEC-RAS model used to estimate the peak flow, but should be considered provisional and updated after rating development using a full reach and cross-section survey.

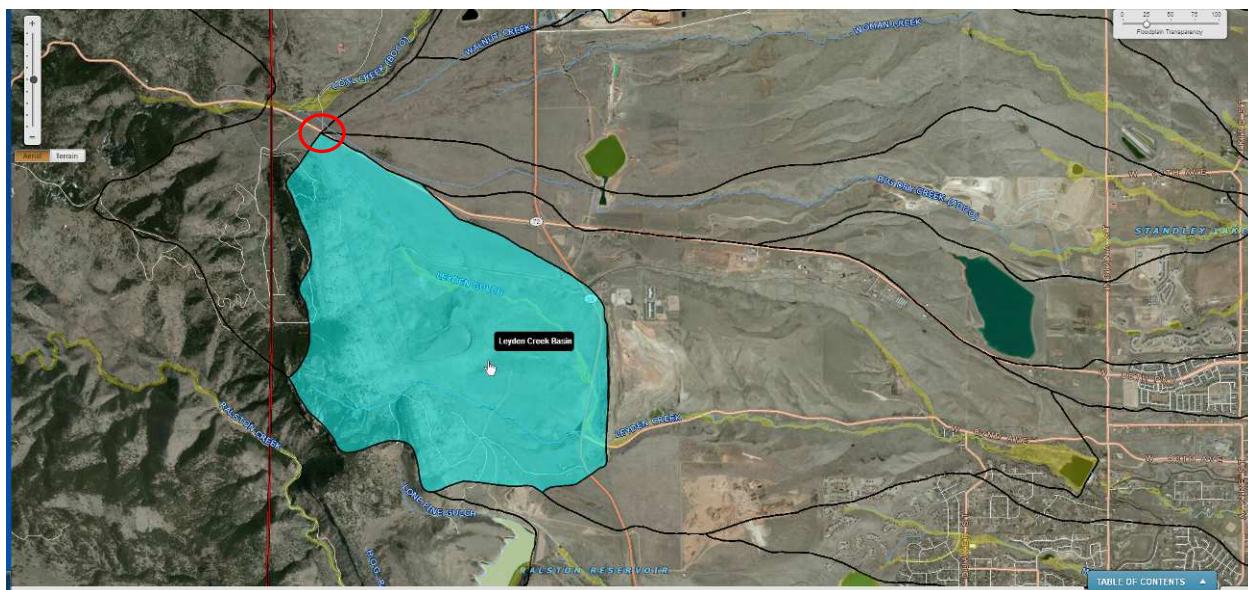
Figure 21. The Upper Leyden Creek Watershed.

The uppermost headwaters portion of the Leyden Creek drainage basin (highlighted in blue) is shown on Figure 21 as it appears on the UDFCD Electronic Data Mapping (EDM) webpage, with its unofficial 100-year floodplain highlighted in pale yellow (The official 100-year floodplain map is available from FEMA or from Arvada). The EDM map shows basin delineations for the headwaters of a large number of creeks (Rock Creek, Walnut Creek, Woman Creek, Big Dry Creek, Barbara Gulch, Leyden Gulch) converging on a relatively flat plateau at the mouth of Coal Creek Canyon (circled in Figure 21). Basin delineations in this area are difficult due to the topography, and during the September 11-13 event, a clogged culvert caused runoff that theoretically should drain to Coal Creek to be captured by Leyden Gulch. The most upstream extent of Barbara Gulch's drainage basin may also be underestimated.

Runoff from most of Blue Mountain Estates, an area of about 1.32 square miles, is intended to pass beneath a railroad embankment and then beneath Blue Mountain Road in CMP culverts that direct flow towards Coal Creek. During the September 2013 event, however, the culvert beneath Blue Mountain Road became clogged with debris and flow began to travel along the East side of Blue Mountain Road, eventually scouring the shoulder of the road. The channel eroded by this flow was up to 10 feet deep and was repaired over the course of the week following the flooding with 2,000 tons of fill material. Flows exposed but did not damage a gas line.

A peak flow estimated at 280 cfs passing under the railroad embankment in a 6 foot diameter CMP culvert was diverted into Leyden Gulch. Supporting documentation for the estimate is provided in Appendix A. The total extra volume entering Leyden Detention Reservoir from this inter basin transfer is unknown, but the additional 1.32 square miles of drainage area increases the watershed area tributary to Leyden Detention Reservoir (8.83 square miles without the Blue Mountain Estates area) by about 15%.

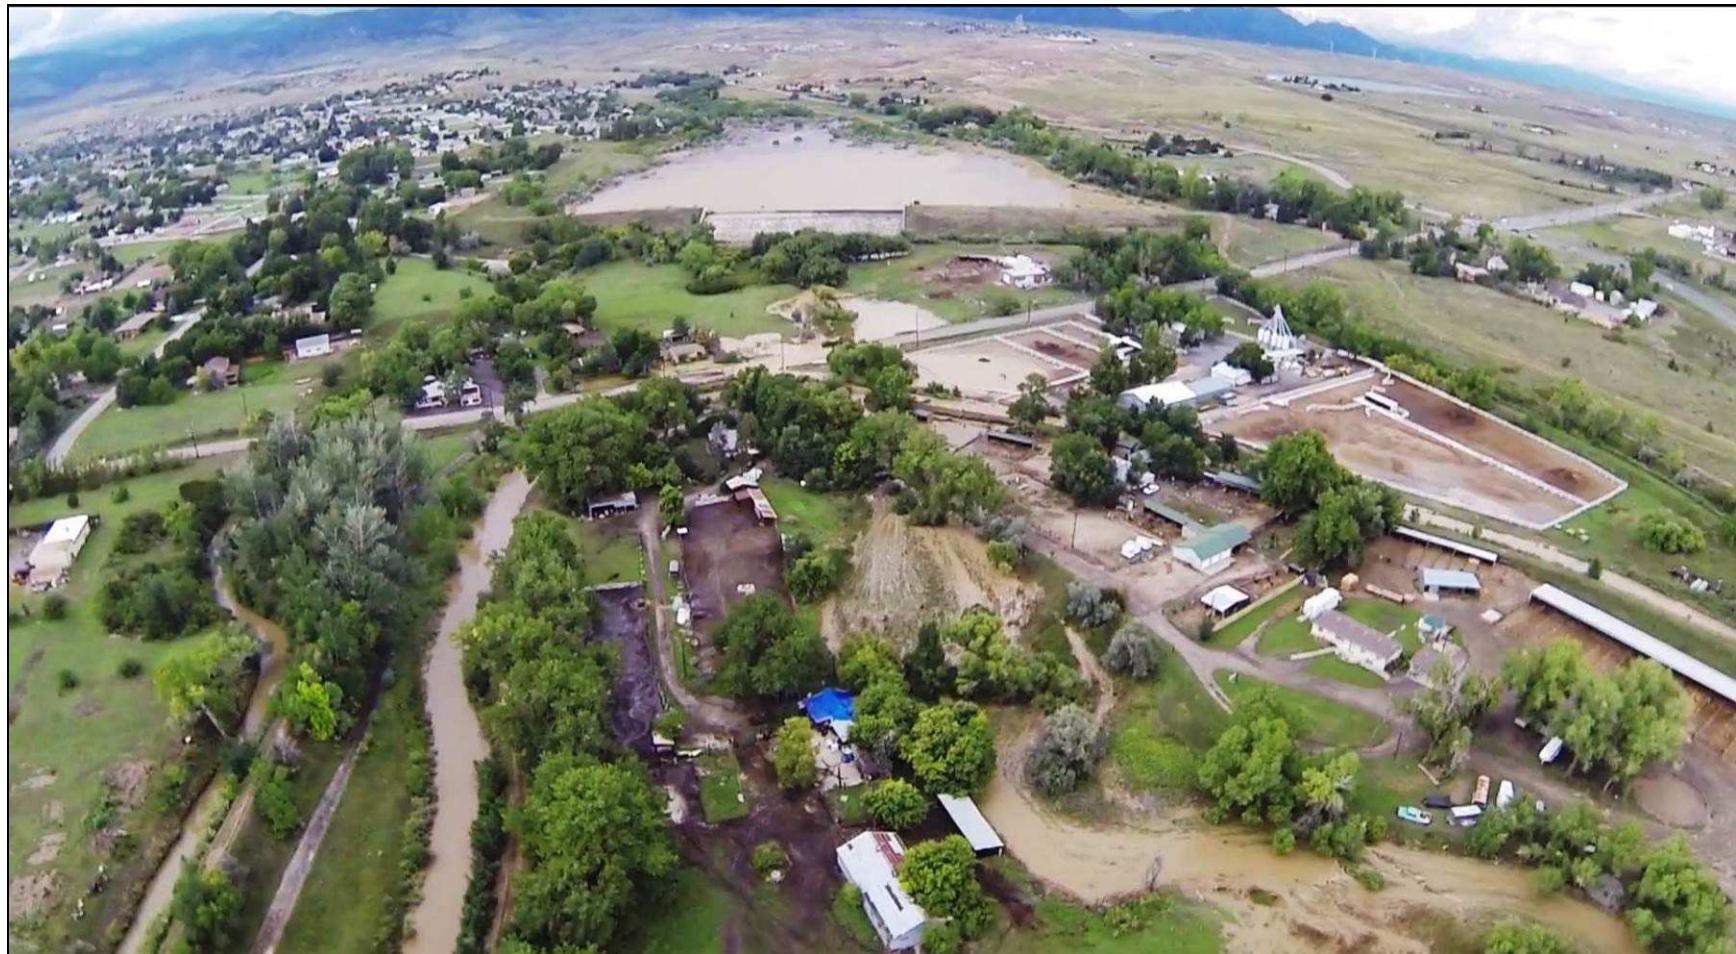
Figure 26. Aerial View of Leyden Reservoir, Leyden Creek at Indiana Street and Croke Canal During Flood.

The spillway release caused significant inundation in areas downstream described in following sections. An aerial view of Leyden Reservoir during the spillway release and showing areas of flooding downstream, shot Friday, September 13, 2013, is provided (Figure 26) (video of the flyover is available online at:

The conveyance for Leyden Creek beneath Indiana during the event (a 36" and an 18" pipe) was known to have inadequate capacity prior to the September flooding. The overtopping of Indiana St. by flows in Leyden Creek is a relatively frequent event, according to Arvada Public Works Department personnel. Its overtopping during the September 11th-13th flood event preceded the release from the Leyden Detention spillway and may have been exacerbated by debris clogging the culverts. By 11:00 or 11:30 p.m. on Wednesday night it had been reported that 3 inches of

flow was passing over Indiana Street and ultimately the roadway was inundated by flows up to a foot deep (Figure 27). The east shoulder of Indiana St. was eroded, exposing an 18" water main encased in a 36" concrete pipe (Figure 28). Arvada was able to quickly mobilize a contractor to place a line of concrete jersey barriers to stabilize the water main and it did not break during the event. Repairs to the road after the September 11th – 13th event included upgrading the conveyance for Leyden Creek beneath Indiana St. to triple 36" CMPs. Additional improvements are planned by CDOT but awaiting the completion of the Northwest Bypass. Indiana Street was the last street to reopen after the September flooding, on Wednesday, October 16.

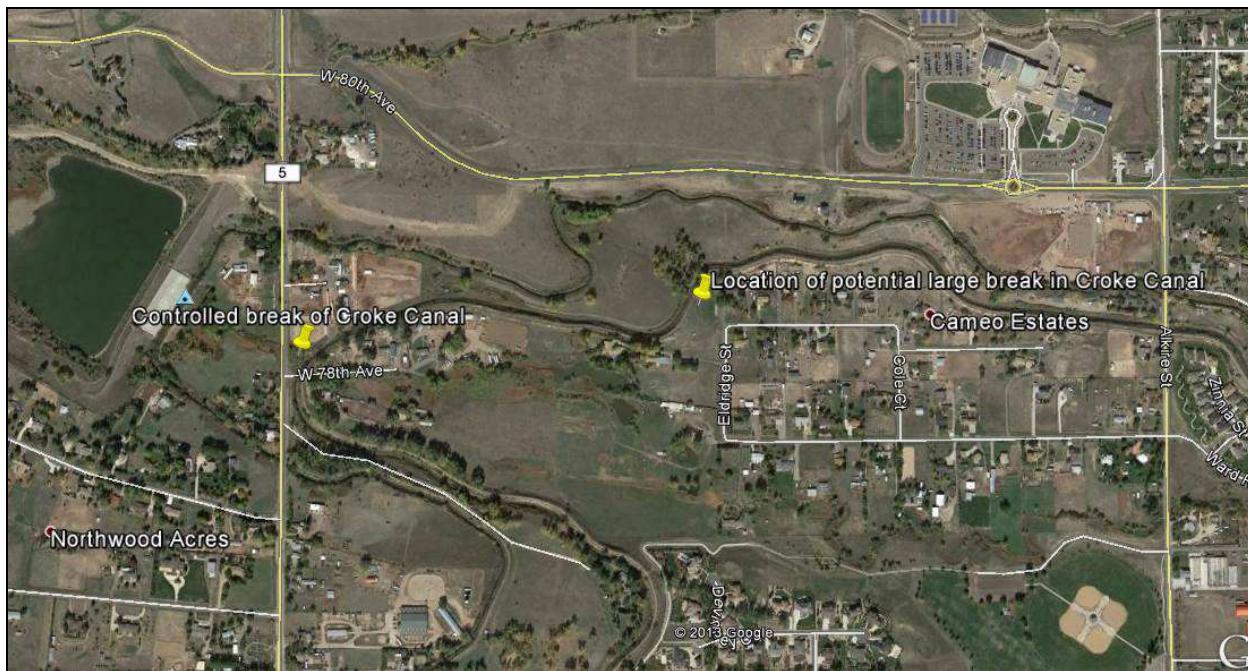
Figure 33. Location Map of Croke Canal Break Area.

Although releases from Leyden Dam were receding by early Friday morning, the Croke Canal continued to be overtopped at scattered locations. At Eldridge and 78th (Figure 33), flows over the downstream embankment of the Croke Canal had seriously eroded the embankment by Friday morning. The width of the top of the embankment had been reduced to about 5 feet from about 30 feet, and complete breach of the canal appeared imminent unless mitigation efforts were employed immediately. A breach in this location would have caused dangerous and serious flooding to adjacent properties. City crews were dispatched to place material to reinforce the embankment. In addition it was decided to open the Croke Canal at a location not far upstream (just east of Indiana St., where the upstream edge of the canal was also being overtopped at its intersection with Leyden Creek, see Figure 33) to relieve pressure on the vulnerable embankment at Eldridge and 78th.

At Eldridge and 78th, the embankment that contains the Croke Canal is built above the natural ground surface, and Arvada Public Works personnel feared that a breach there would release more of the flow in the Canal than a controlled opening at Indiana St. A survey conducted on November 1st confirms this assumption. Figure 34 shows a rodman holding a 16-foot survey rod at the native ground surface beneath the repaired embankment that was overtopping at Eldridge and 78th. The disturbed foreground area is due to the repair of the embankment. The invert of

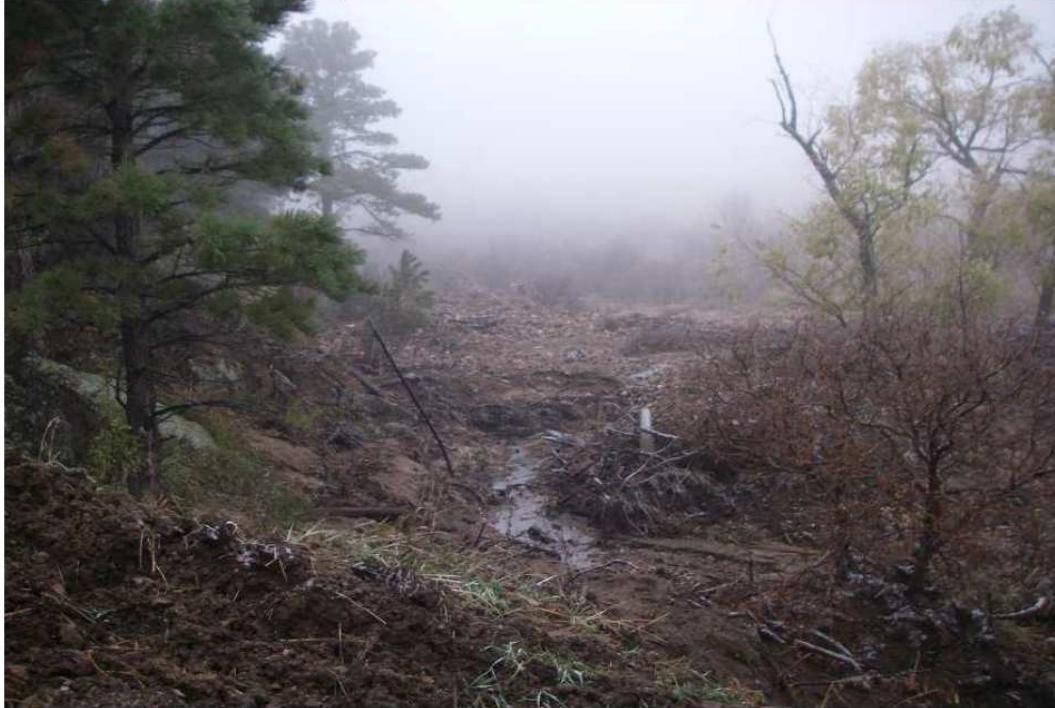
Above culvert looking upstream

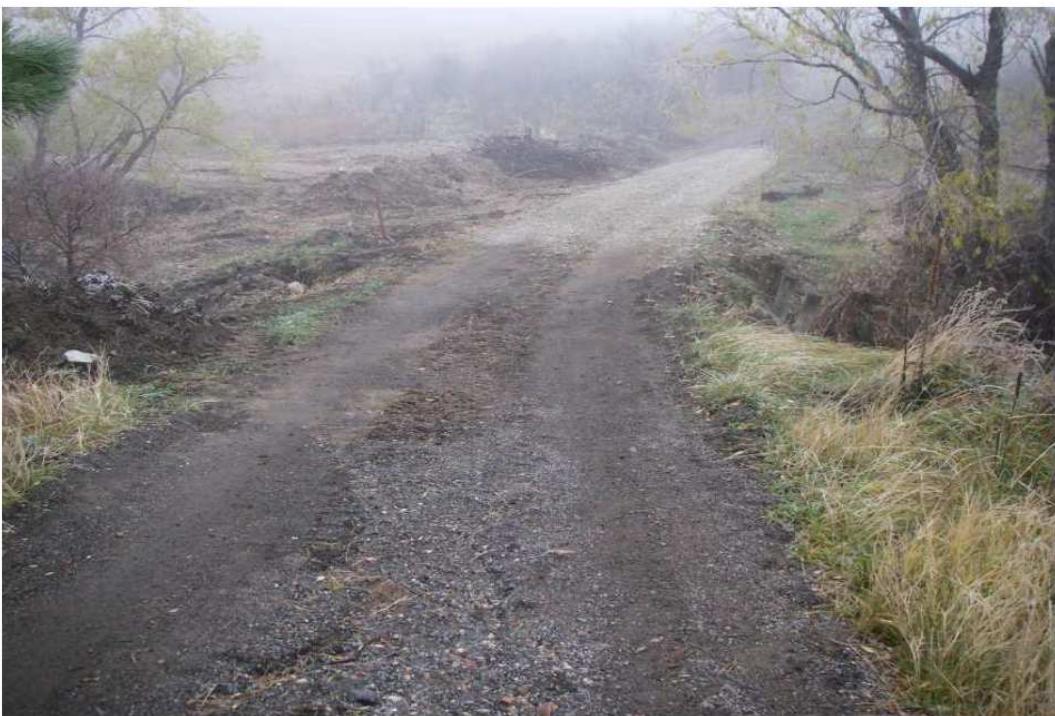
Gravel road upstream of culvert

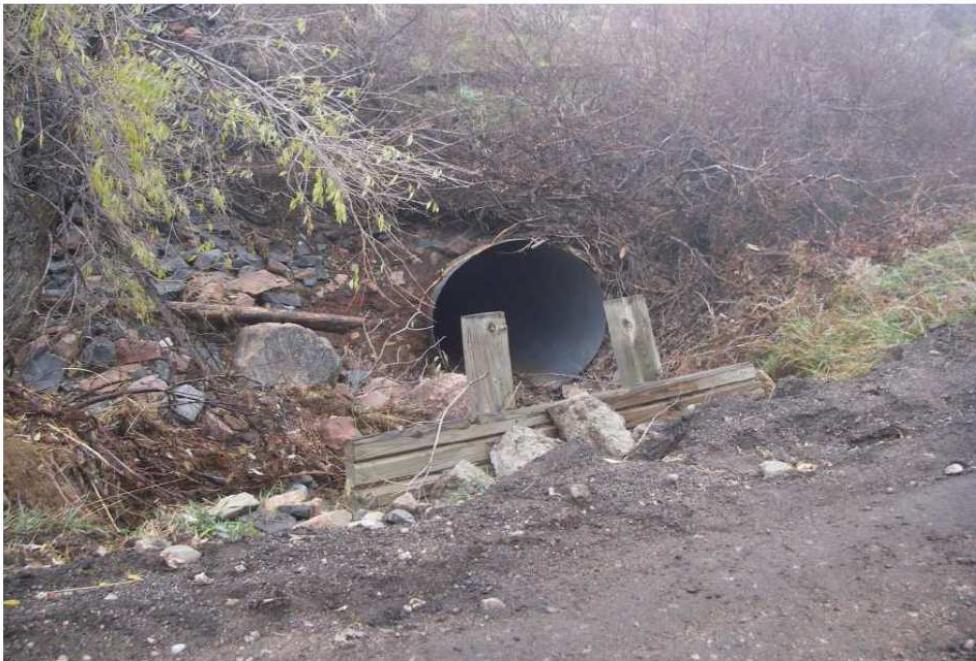
Upstream entrance to culvert under RR tracks, just downstream of gravel road

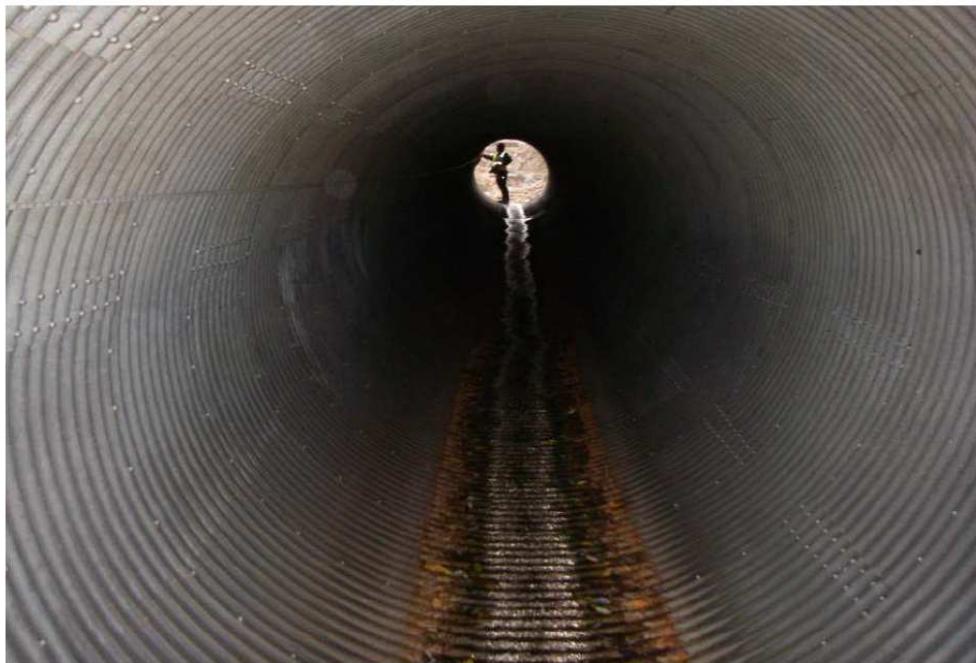
Looking downstream through culvert

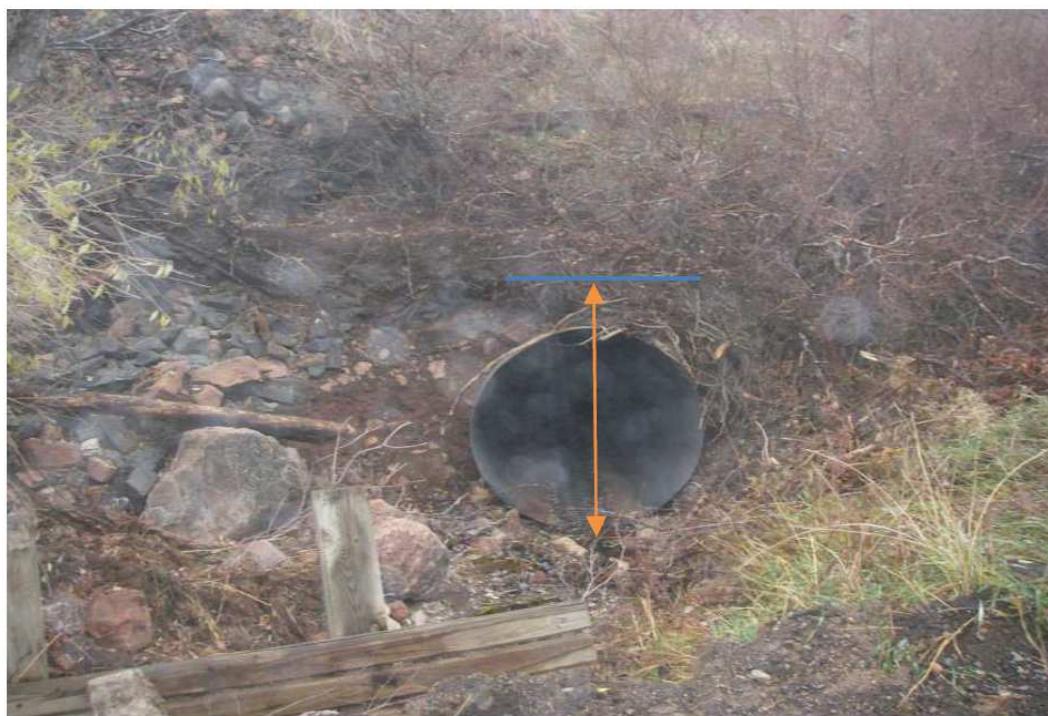
Upstream entrance and high water debris line
